Item #15260646 - 2023 Doosan DX140LCR-7 Tracked Excavator

Inspection Report

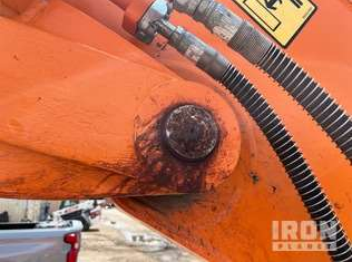
<p>Pin and Bushings Boom to Stick</p>	<p>★ ★ ☆ ☆ Movement</p>

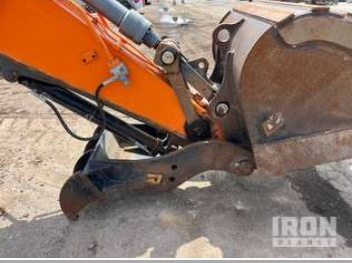
<p>Pin and Bushings Stick to Bucket</p>	<p>★ ★ ☆ ☆ Movement</p>

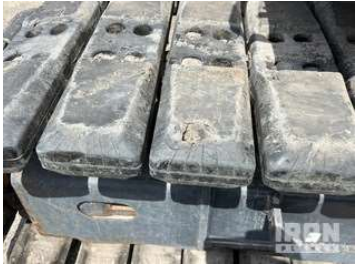
Left Track Pads	★☆☆☆☆ 23.5 in Wide Worn damaged

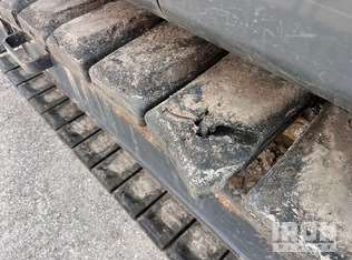
Right Track Pads	★★★☆☆ 23.5 in Wide Worn damaged

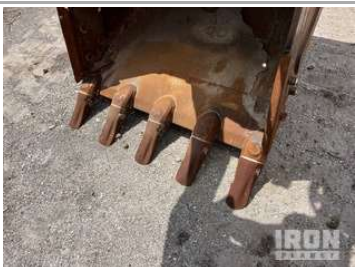
Bucket Cutting Edge/Shanks/Teeth	Wear
