## Item #13749008 - Develon DX140LCR-7 Tracked Excavator

- Features: Air Conditioner, Control Pattern Changer, 2023 US EPA Label, Requires Diesel Exhaust Fluid, 9 ft 10 in Stick, Auxiliary Hydraulic Plumbing, Backfill Blade, Hydraulic Quick Coupler, 42 in Digging Bucket, Hydraulic Thumb
- Meter Reading: 673 Miles
- Serial # : DHKCEBDUCP0001415
- Inspection Completed: 8/15/25

# Inspection Report

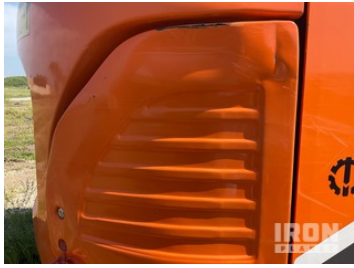
| Body Panels | Left Side Cover damaged, Right rear door damaged, Right side cover damaged | |

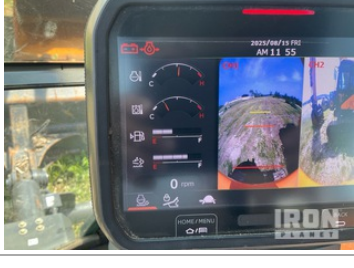
| Engine Oil Pressure | The fault indicator shuts off after the engine oil pressure rises. | |

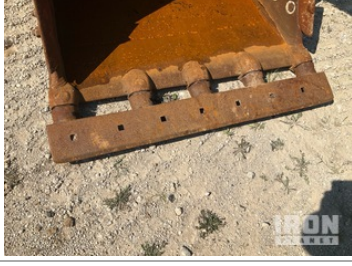
| Specialty | | |
|---|---|---|
| Bucket Cutting<br>Edge/Shanks/Teeth | ★★★☆☆<br>Plate welded across the teeth | |

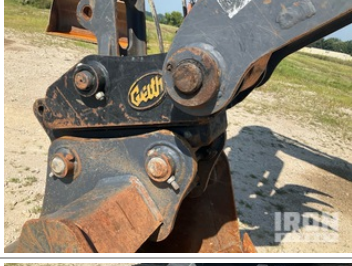
| Specialty | | |
|---|---|---|
| Quick Coupler | Not operationally checked | |
