Item #15091758 - 2020 Doosan DL200-5 Wheel Loader

Inspection Report

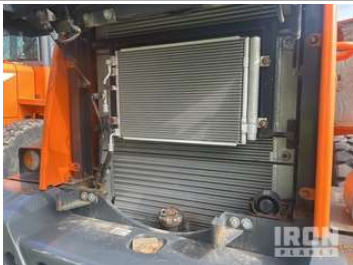
| Engine | | |
|---|--|--|
| Radiator | ★★★★☆ | |

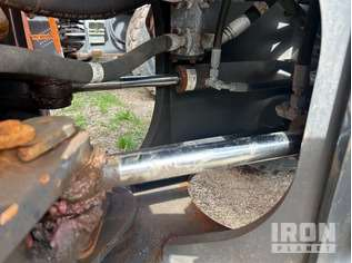
| Steering Cylinders | ☆☆☆☆ | |

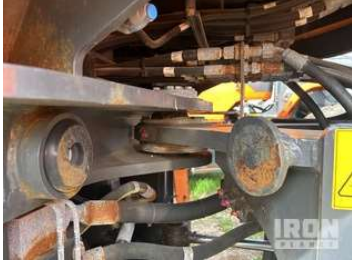
| Item | Assessment | Photo |
|---|--|--|
| Articulating Center Pins | ★★★★☆ | |

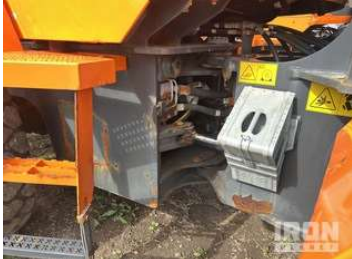
| Item | Assessment | Photo |
|---|--|--|
| Frame Condition | ★★★★☆ | |

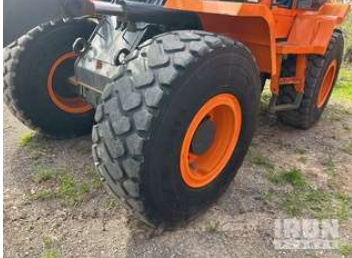
| Item | Assessment | Photo |
|---|--|--|
| Left Front Tire | ★★★☆☆ triangle TB516 20.5 R25 22/32" Tread Depth | |

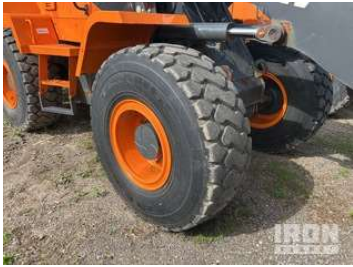
| <p>Right Front Tire</p> | <p>★★☆☆☆ 22/32" Tread Depth</p> | |

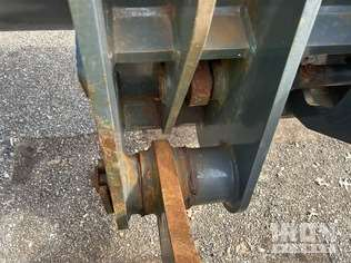
| Quick Coupler to Arms Pins | ☆☆☆☆ | |

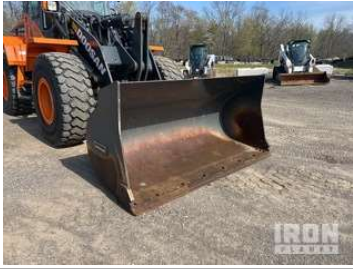
| Item | Assessment | Photo |
|---|--|--|
| Loader Bucket Condition | ★★☆☆☆ | |

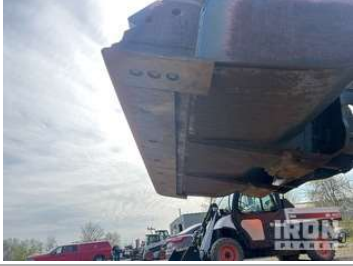
| Item | Assessment | Photo |
|---|--|--|
| Loader Bucket Cutting Edge | ★★☆☆☆ No visible damage or missing components | |

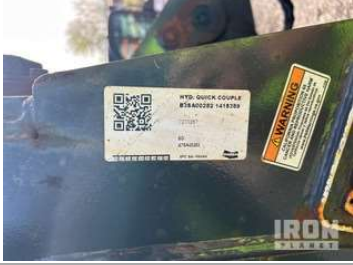
| Item | Assessment | Photo |
|---|--|--|
| Loader Quick Coupler | ★★☆☆☆ Operational | |
