## Item #15091759 - 2020 Doosan DL200-5 Wheel Loader

# Inspection Report

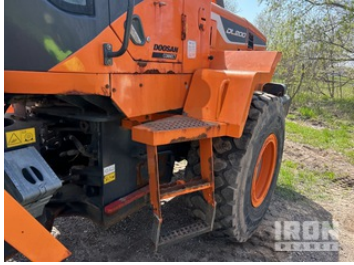
| Paint | Damage | |

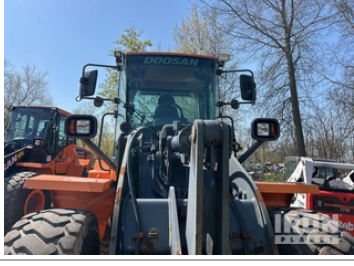
| Exterior Lights | All lights operational Switches would not operate lights | |

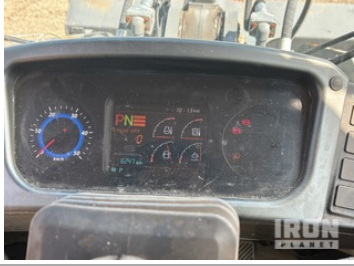
| Engine Oil Pressure | The fault indicator shuts off after the engine oil pressure rises. | |

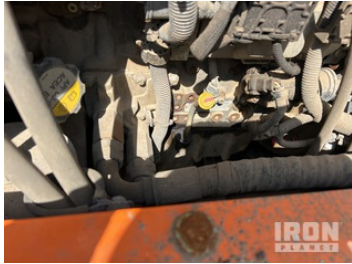
| Engine | | |
|---|---|---|
| Oil Leaks | No dripping leaks | |

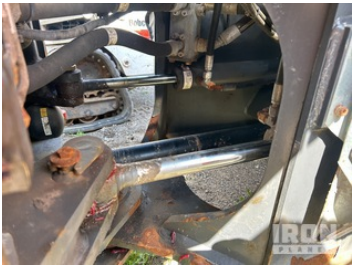
| Steering Cylinders | ☆☆☆☆ | |

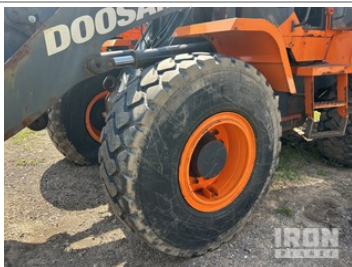
| Item | Assessment | Photo |
|---|---|---|
| Left Front Tire | ★★★☆☆<br>triangle TB516 20.5r25 23/32" Tread Depth | |

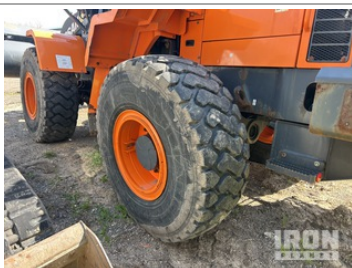
| Item | Assessment | Photo |
|---|---|---|
| Left Rear Tire | ★★★★☆<br>29/32" Tread Depth | |

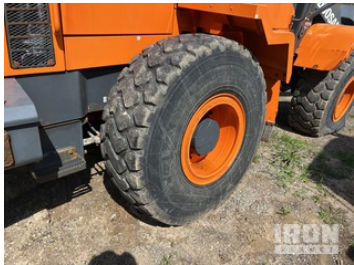
| Right Rear Tire | <br>28/32" Tread Depth | |

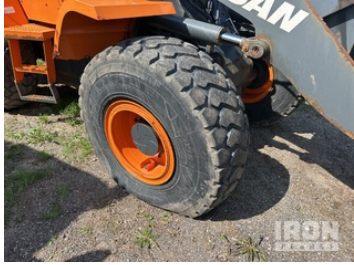
| Right Front Tire | <br>26/32" Tread Depth | |
