Item #14787771 - 2023 Develon DL250-7 High Lift Wheel Loader

Inspection Report

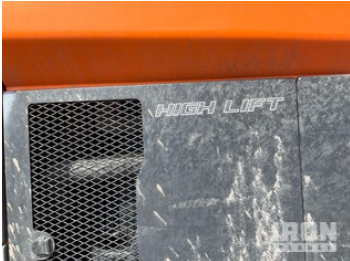
Paint	Damage	 
Body Panels	Right rear door damaged	
Fenders	Rust/ Corrosion Left, cab entry platform. DEF compartment/ Platform	 
Steps	Left cab steps damaged	 
Hand Rails	No visible damage or missing components	 
Exterior Lights	All lights operational	 
Wheel Loader* # 1

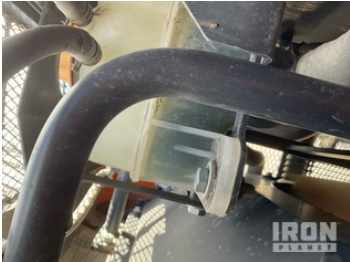
Radiator	★★★★☆ Unable to remove cap, bolt down cover

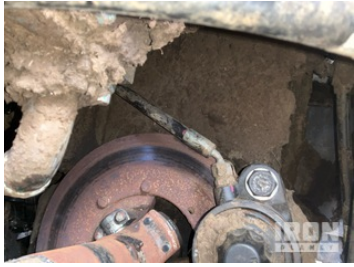
Drivetrain		
Item	Assessment	Photo
Transmission	★★☆☆ Operational

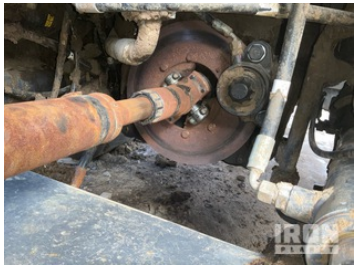
Transfer Case / Drop Box	★★☆☆

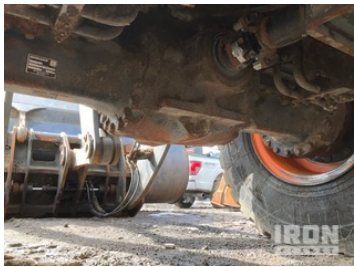
Front Drive Axle	★★☆☆

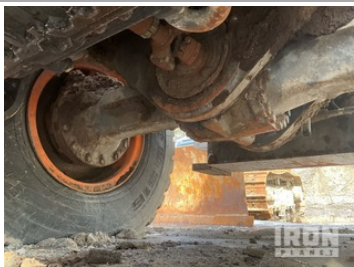
Rear Drive Axle	★★☆☆

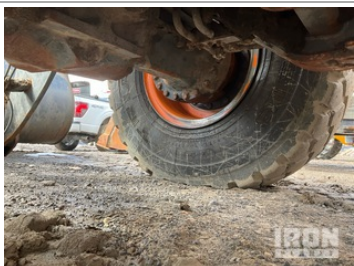
Final Drives	★★☆☆

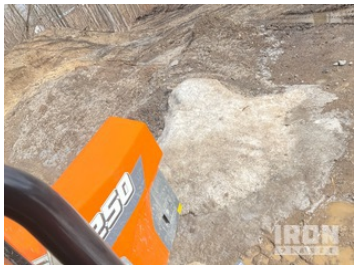
Hydraulic Tank	★ ★ ☆ ☆ Low fluid level, Just below sight glass

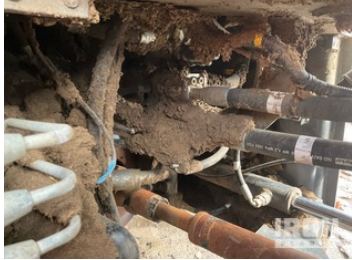
Limited Function Check	The hydraulic system was operational. Heavy buildup up Silage, mud, and Manure prevented a more thorough inspection no leaks etc. were observed	
Hydraulics #1

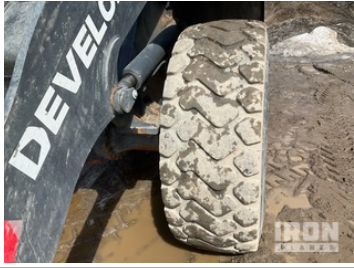
Left Front Tire	★★★☆☆ Triangle TB 516 20.5R25 18/32" Tread Depth ALL (4) TIRES ARE SAME BRAND, SIZE, MODEL

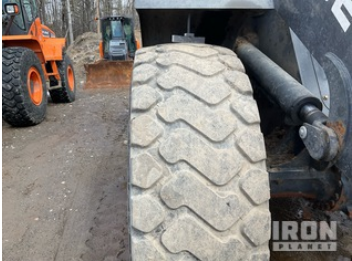
Right Front Tire	★★☆☆ 17/32" Tread Depth

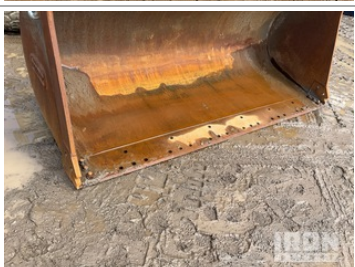
Loader Bucket Cutting Edge	★☆☆☆ Edge missing No bolt on edge
