## Item #15293229 - 2021 Doosan DX420LC-5 Tracked Excavator

# Inspection Report

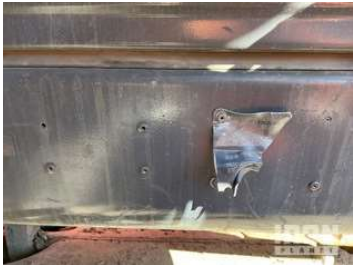
Serial Number / VIN	DWGCECBFPM1010129, Damaged/Missing data plates, serial number obtained from ecm

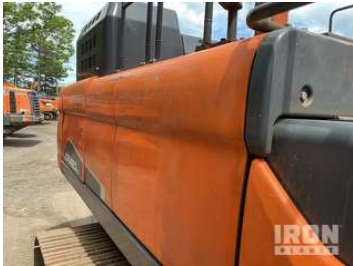
Paint	Damage	 
Body Panels	Left rear door damaged, Right rear door damaged, Right side cover damaged

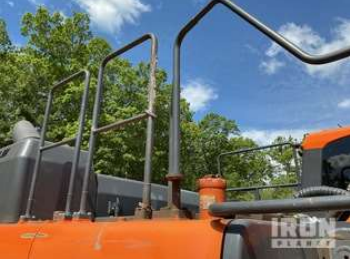
Mirrors	Right side top mirror is missing.

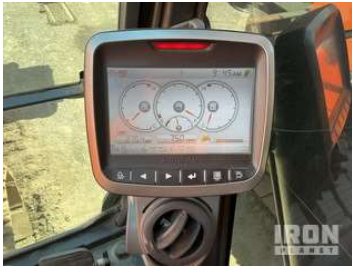
Engine Oil Pressure	The fault indicator shuts off after the engine oil pressure rises.

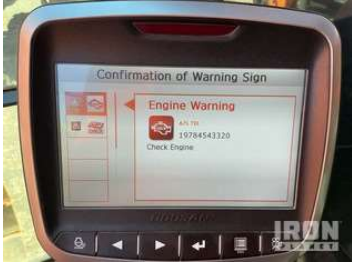
Warning Lights	Service Machine Before Restarting Code and Engine Warning Lights are on

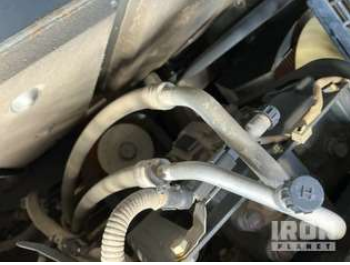
A/C Compressor	Compressor will not engage

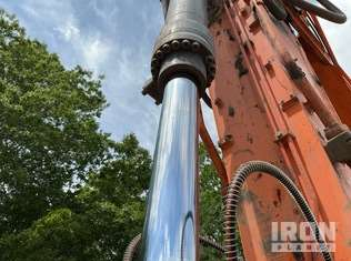
Bucket Cylinder	★★★★☆ Fluid residue on rod with minor scratches, no dripping leaks.

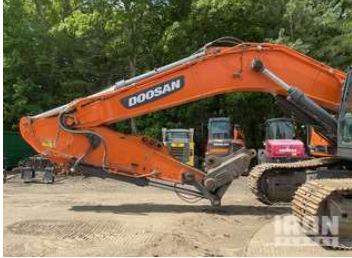
Stick Condition	★★★★☆ Plated on inside with grapple bracket.

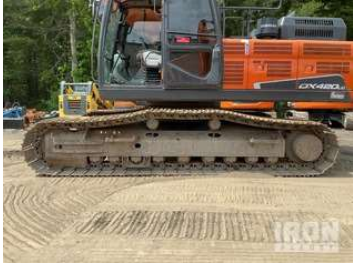
Item	Assessment	Photo
Track Link Brand	Other Doosan Other Doosan	
Left Roller Frame	★★☆☆ Rock Guard missing at #7 track roller, broken bolts in track frame

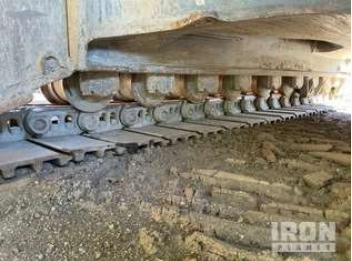
Left Bottom Rollers	<p>9 Bottom Rollers #1 unable to measure mm #2 unable to measure mm #3 unable to measure mm #4 unable to measure mm #5 196 mm #6 196 mm #7 196 mm #8 197 mm #9 197 mm</p> <p>Rock Guard missing at #7, broken bolts in track frame</p>
