Item #15091771 - 2023 Doosan DX350LCR-7 Tracked Excavator

Inspection Report

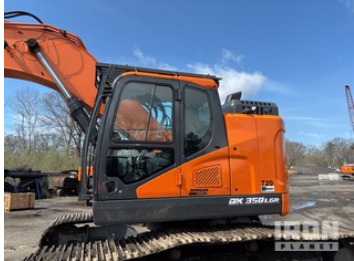
<p>Body Panels</p>	<p>Left Side Cover damaged, Right rear door damaged, Right side cover damaged</p>

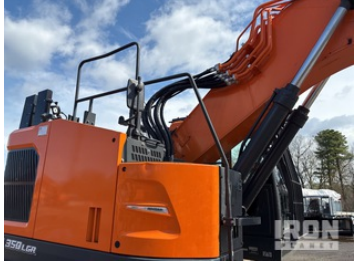
<p>Exterior Lights</p>	<p>1 Inoperable / damaged / missing</p>

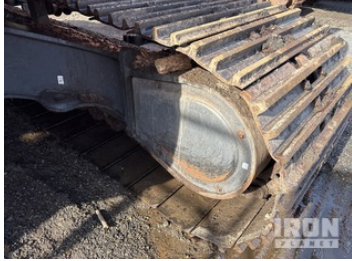
Right Drive Motor	★★★★☆

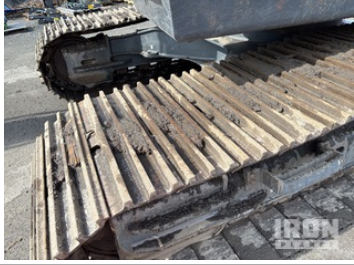
Left Grouser Height	32 mm

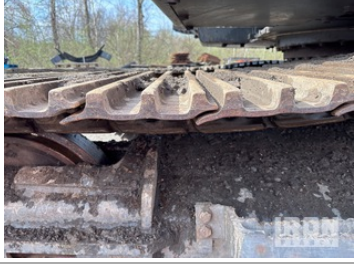
Left Track Links	112 mm

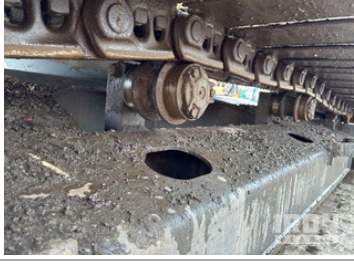
Left Track Bushings	64 mm
