Item #13331829 - 2021 Doosan DL550-5 Wheel Loader

Inspection Report

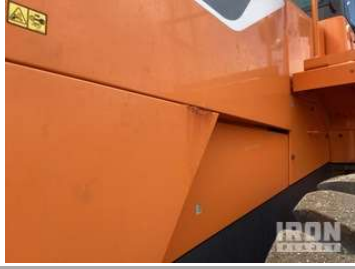
Paint	Damage/Rust

Body Panels	Left side cover missing, Right side cover heavy rust / corrosion, Right battery box damaged, Grille damaged, Door hinges very Rusty	
Fenders	Left front damaged, Right front damaged, Rust	 
Steps	No visible damage or missing components.	 
Hand Rails	No visible damage or missing components

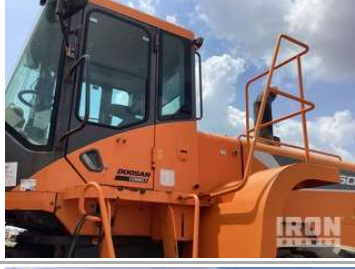
Exterior Lights	3 Inoperable / damaged / missing

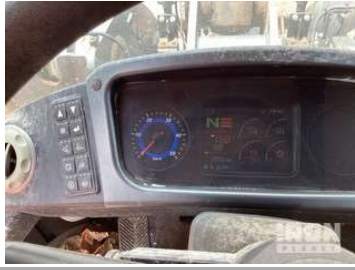
Dash Console	★☆☆☆☆ Will not change

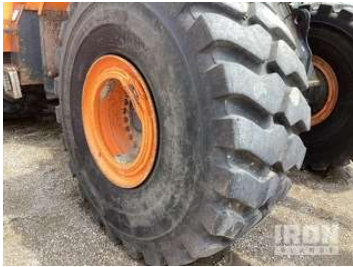
Right Front Tire	★★☆☆ Bridgestone 29.5R25 65/32" Tread Depth

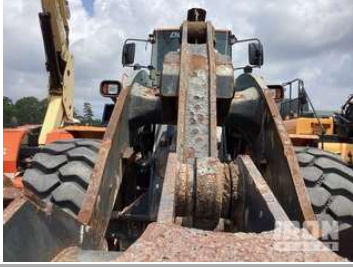
Lift Arm Condition	★★☆☆ Rusty

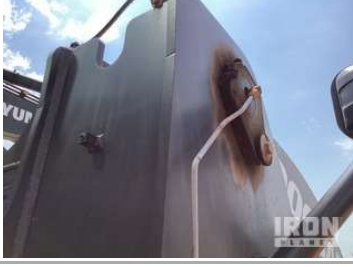
Chassis to Arm Pins	★★☆☆

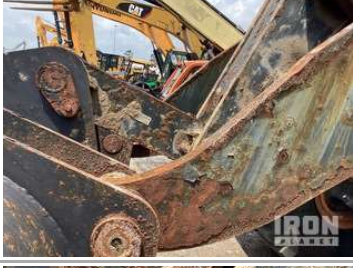
Tilt Linkage	★★☆☆ Rusty

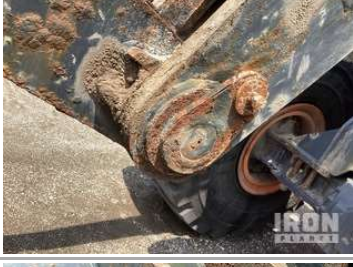
Tilt Linkage Pins and Bushings	★★☆☆

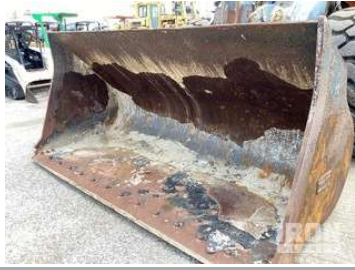
Wheel Loader*		
Item	Assessment	Photo
Loader Bucket Condition	★★☆☆ Rusty

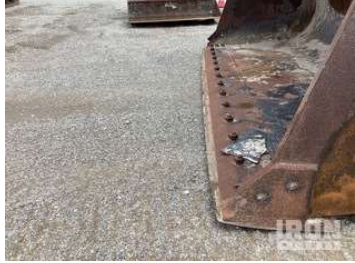
Loader Bucket Cutting Edge	★★☆☆ Edge worn
