Item #15260640 - 2023 Doosan DL280-7 Wheel Loader

Inspection Report

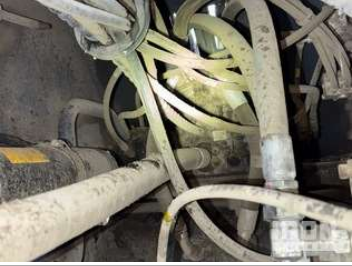
Valves	★★☆☆☆

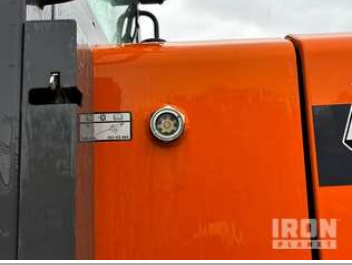
Hydraulic Tank	★★☆☆☆ Low fluid level

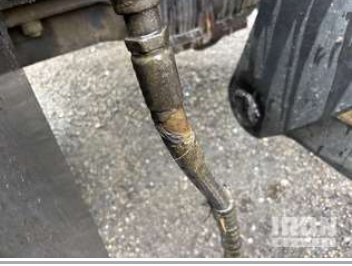
Hoses (Hydraulics)	★★☆☆☆ Blow auxiliary line

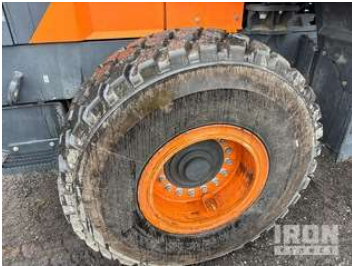
Right Rear Tire	<p>★ ★ ★ ☆</p> <p>Maxam MS330 20.5R25 38/32" Tread Depth</p>

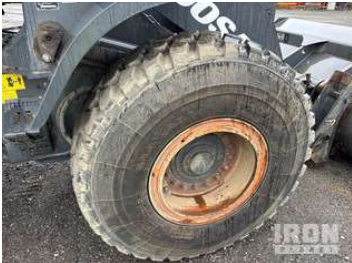
Right Front Tire	<p>★ ★ ★ ☆</p> <p>Maxam MS330 20.5R25 37/32" Tread Depth</p>

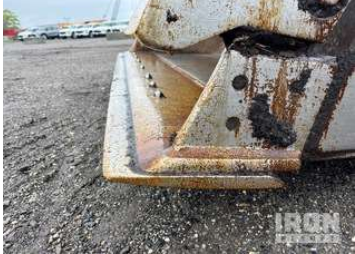
Loader Bucket Cutting Edge	<p>★★★★☆ No visible damage or missing components Edge slightly worn. Reversible not turned</p>

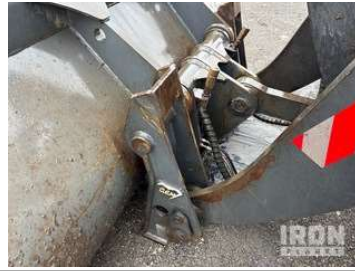
Loader Quick Coupler

Not operational, Pins would not release
