## Item #15516740 - 2021 Doosan DL480-7-US10 Wheel Loader

# Inspection Report

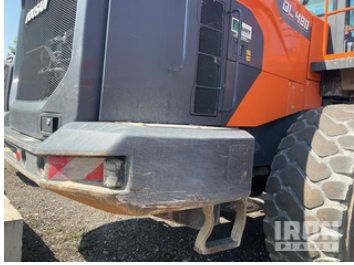
| Paint | Damage | |

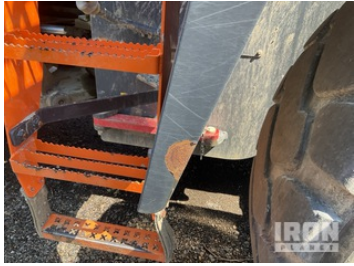
| Fenders | No visible damage or missing components. | |

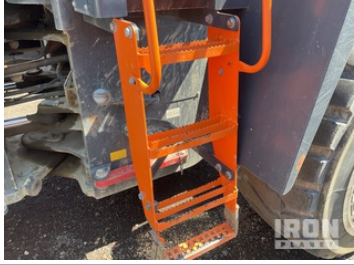
| Steps | Right cab steps bent | |

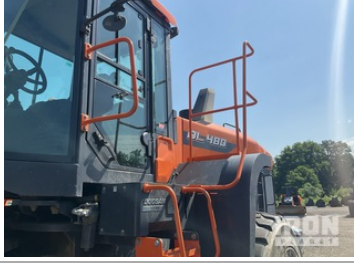
| Hand Rails | No visible damage or missing components | |

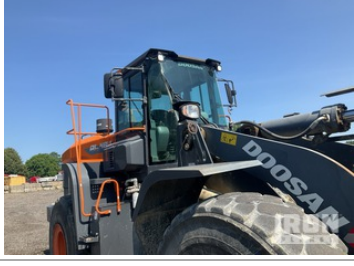
| Exterior Lights | All lights operational | |

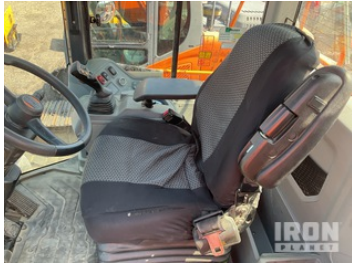
| Control Station | | |
|---|---|---|
| Seat/Armrests | No visible damage or missing components | |

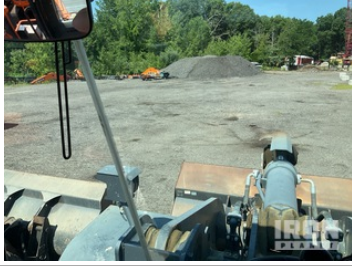
| Control Station | | |
|---|---|---|
| Glass | No visible damage or missing components | |

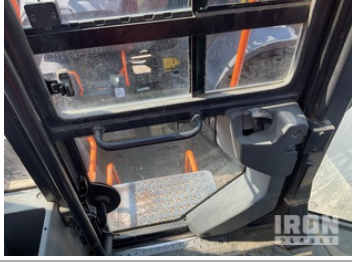
| Control Station | | |
|---|---|---|
| Cab Doors | No visible damage or missing components | |

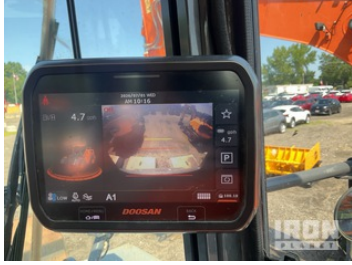
| Rear View Camera | Camera operates as intended | |

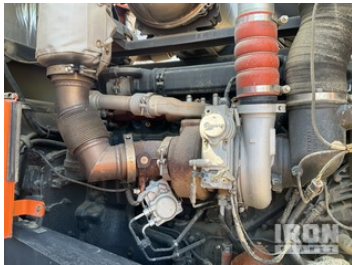
| Engine | | |
|---|---|---|
| Exhaust System | No visible damage or missing components | |

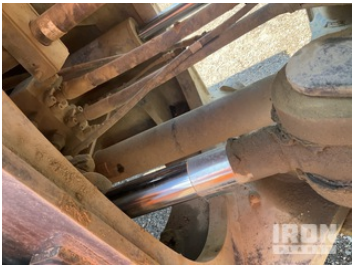
| Steering Cylinders | ☆☆☆☆ | |

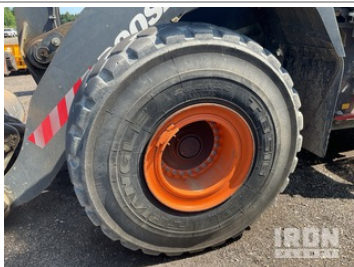
| Item | Assessment | Photo |
|---|---|---|
| Left Front Tire | ★★★☆☆<br>triangle TB516 26.5T25 22/32" Tread Depth | |

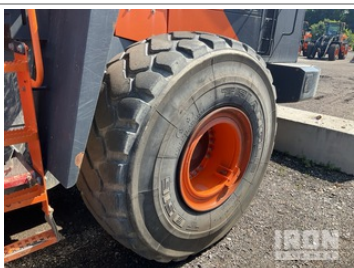
| Item | Assessment | Photo |
|---|---|---|
| Left Rear Tire | ★★★☆☆<br>triangle Tb516 26.5R25 24/32" Tread Depth | |

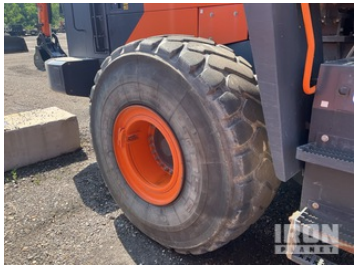
| Right Rear Tire | ★★☆☆<br>triangle Tb516 26.5R25 18/32" Tread Depth | |

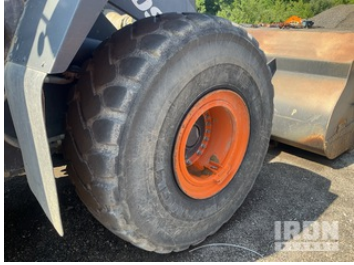
| Right Front Tire | ★★☆☆<br>triangle Tb516 26.5R25 20/32" Tread Depth | |

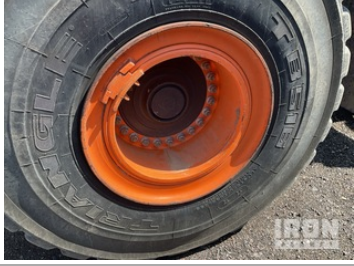
| Wheel Condition | No visible damage or missing components | |

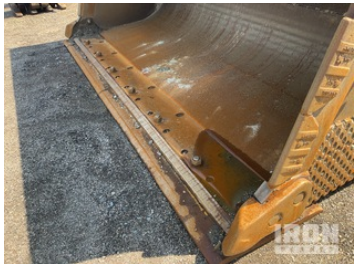
| Specialty | | |
|---|---|---|
| Loader Bucket Cutting Edge | ★★★★☆<br>No visible damage or missing components | |
