2023 DEVELON DX140LCR-7

UNIT: DHKCEBDUAN0001110

UNIT SPECS

RECONDITIONING

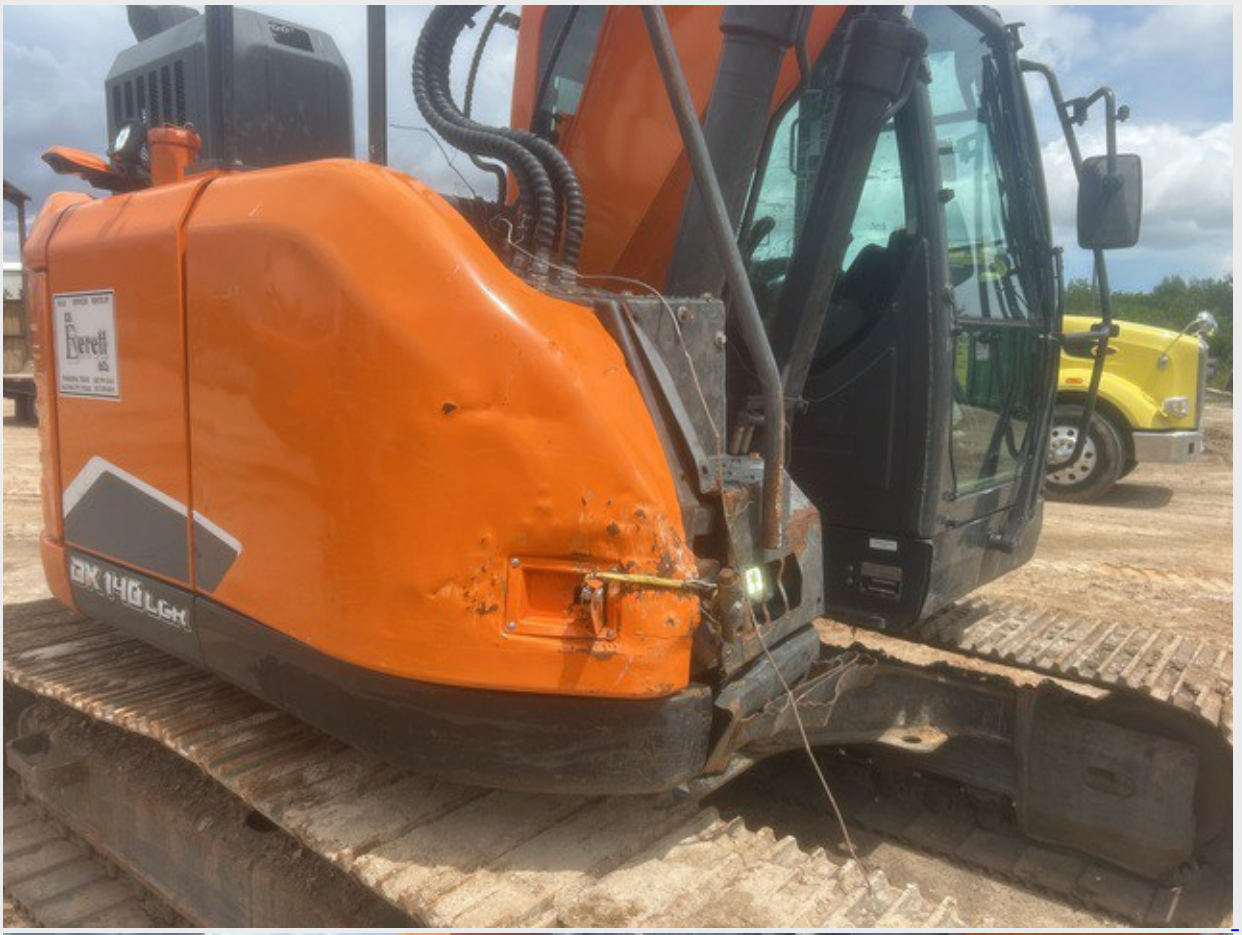
Mirrors: Mirror is missing on the right side	$150
Body Panels: Right front door and panel is damaged.	$4,500
Steps: Tool box step damaged	$300
Bucket Cutting Edge/Shanks/Teeth: Teeth worn	$750
Paint: Damage	$2,500
Panel under front glass is damaged	$2,000
Hand Rails: Cab entry hand rail damaged, Tool box step hand rail damaged	$1,200
