# 2019 DOOSAN DX225LC-5

UNIT: DHKCEBBUCK00026525

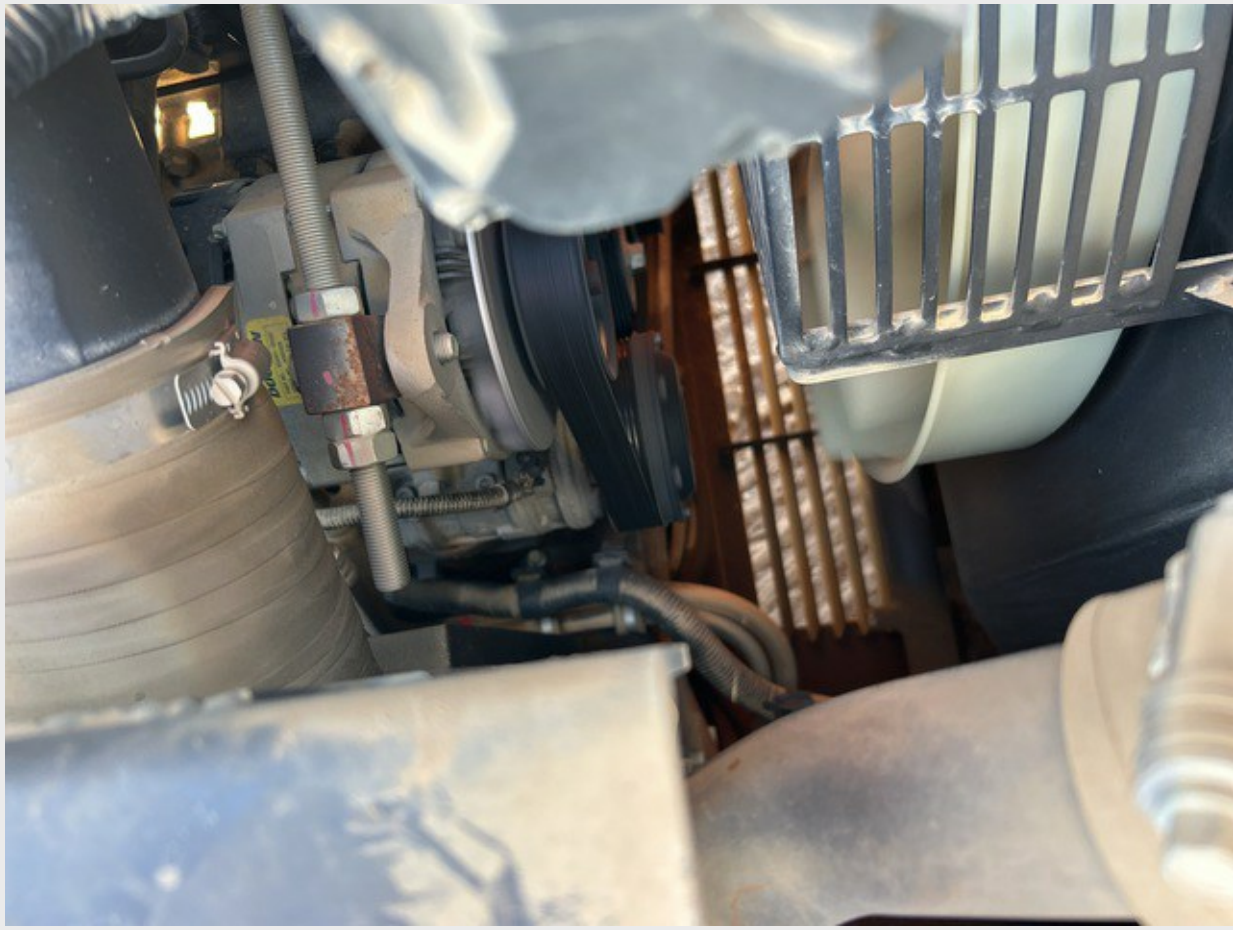
**DOOSAN** EMISSION CONTROL INFORMATION

This Engine complies with U.S. EPA and California regulation for 2019 nonroad diesel engines.

Emission Control System  
: EGR, DOC, SCR, DFI, TC, CAC, ECM, DOS

Power Category : 130 ≤ kW ≤ 560

US Engine Family : KDICL05.0LEA

Engine Code : DLOS-LEE00

Date Of Manufacture : 2019 / 07
