# 2022 DOOSAN DL480-7

UNIT: DWGCWLDRKM1010024

Current Location: BEST LINE EQUIPMENT, Allentown, PA 18104, 570-279-6768

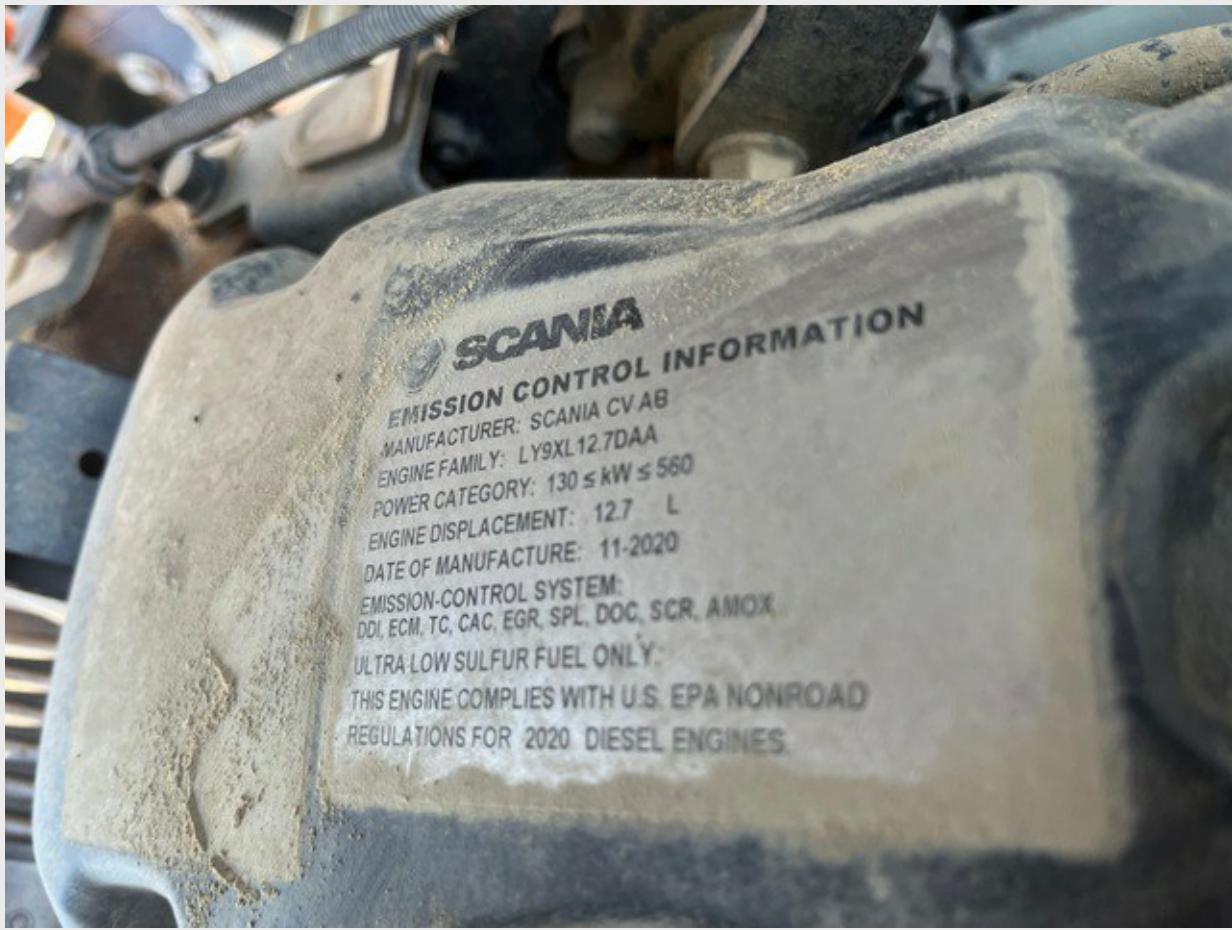
SCANIA  
EMISSION CONTROL INFORMATION  
MANUFACTURER: SCANIA CV AB  
ENGINE FAMILY: LY9XL12.7DAA  
POWER CATEGORY: 130 ≤ kW ≤ 560  
ENGINE DISPLACEMENT: 12.7 L  
DATE OF MANUFACTURE: 11-2020  
EMISSION-CONTROL SYSTEM:  
DOI, ECM, TC, CAC, EGR, SPL, DOC, SCR, AMOX  
ULTRA LOW SULFUR FUEL ONLY  
THIS ENGINE COMPLIES WITH U.S. EPA NONROAD  
REGULATIONS FOR 2020 DIESEL ENGINES.
