## Item #13749008 - Develon DX140LCR-7 Tracked Excavator

- Features: Air Conditioner, Control Pattern Changer, 2023 US EPA Label, Requires Diesel Exhaust Fluid, 9 ft 10 in Stick, Auxiliary Hydraulic Plumbing, Backfill Blade, Hydraulic Quick Coupler, 42 in Digging Bucket, Hydraulic Thumb
- Meter Reading: 673 Miles
- Serial # : DHKCEBDUCP0001415
- Inspection Completed: 8/15/25

# Inspection Report

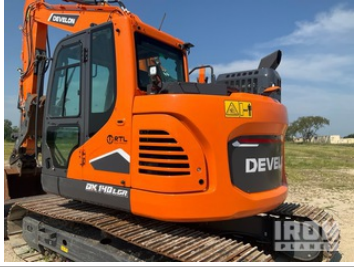
| Paint | No visible damage | |

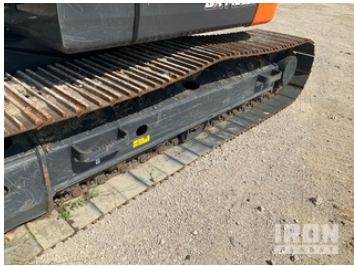
| Steps | No visible damage or missing components | |

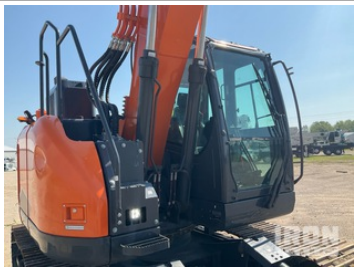
| Hand Rails | No visible damage or missing components | |

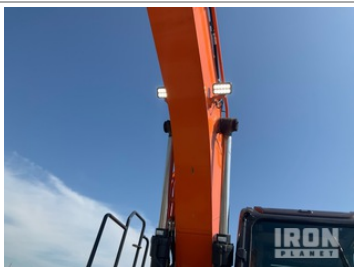
| Exterior Lights | All lights operational | |

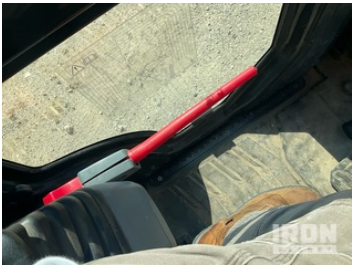
| Safety | | |
|---|---|---|
| Safety Lock Out/Stop | Operational | |

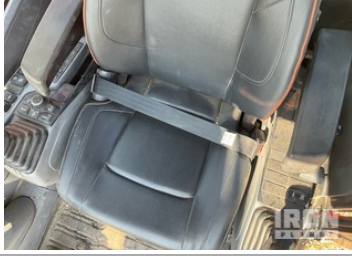
| Control Station | | |
|---|---|---|
| Seat/Armrests | No visible damage or missing components | |

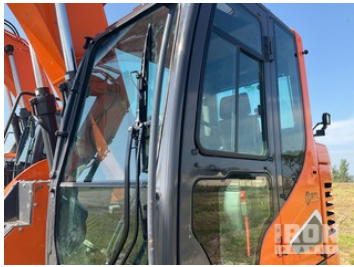
| Glass | No visible damage or missing components | |

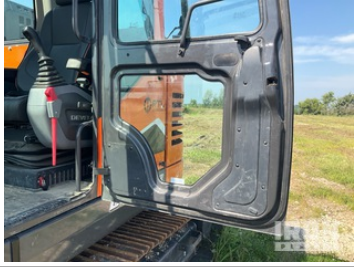
| Cab Door | No visible damage or missing components | |

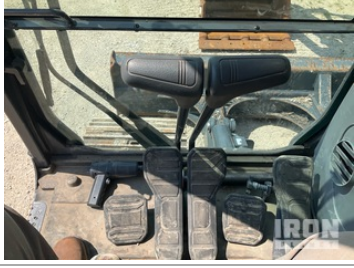
| Steering Controls | ★★★★☆ | |

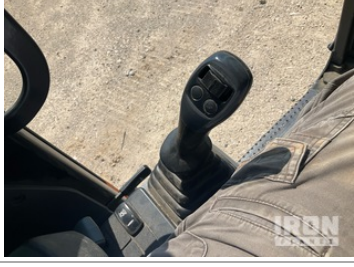
| Hydraulic Controls | ★★★★☆ | |

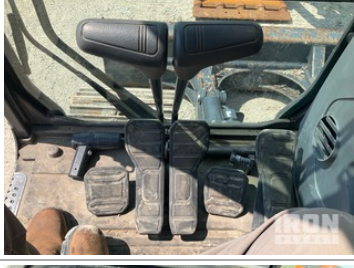
| Drivetrain Controls | ★★★★☆ | |

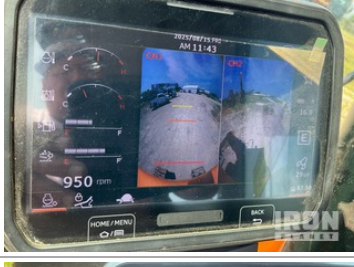
| Dash Console | ★★★★☆ | |

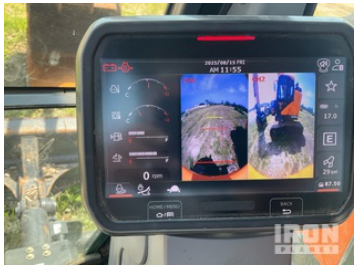
| Warning Lights | Operational | |

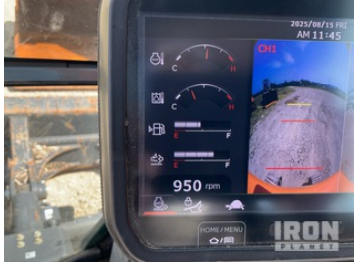
| Gauges | Operational | |

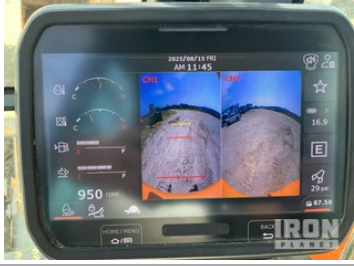
| Rear View Camera | Camera operates as intended | |

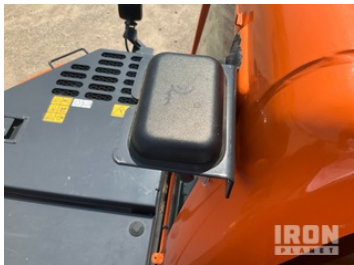
| Grade Control Antenna | Unable to test | |

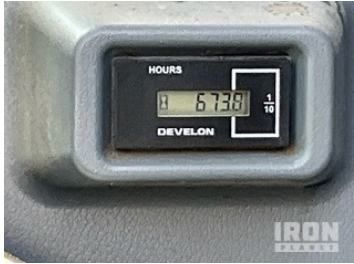
| Hour Meter / Odometer | 673 mi | |

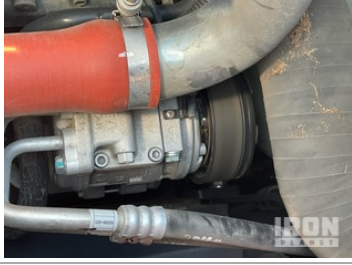
| Engine | | |
|---|---|---|
| A/C Compressor | Operational | |

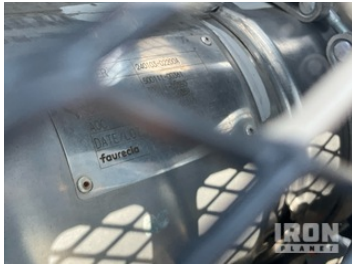
| Engine | | |
|---|---|---|
| Exhaust System | No visible damage or missing components | |

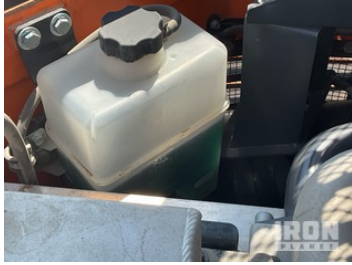
| Engine | | |
|---|---|---|
| Radiator | ★★★★☆ | |

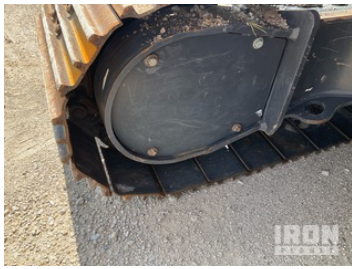
| Item | Assessment | Photo |
|---|---|---|
| Left Drive Motor | ★★★★☆ | |

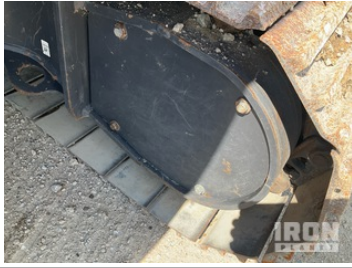
| Item | Assessment | Photo |
|---|---|---|
| Right Drive Motor | ★★★★☆ | |

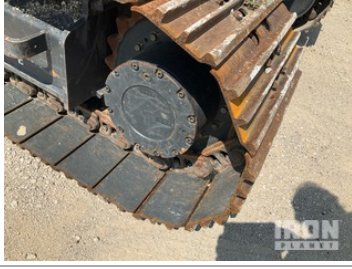
| Item | Assessment | Photo |
|---|---|---|
| Left Final Drive | ★★★★☆ | |

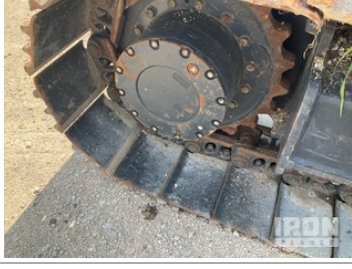
| Item | Assessment | Photo |
|---|---|---|
| Right Final Drive | ★★★★☆ | |

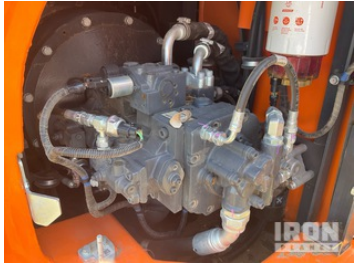
| Hydraulics | | |
|---|---|---|
| Pumps (Hydraulics) | ★★★★☆ | |

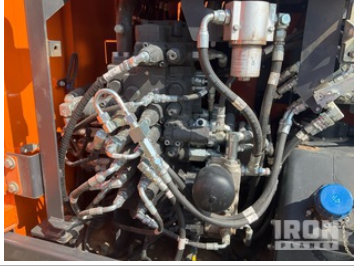
| Hydraulics | | |
|---|---|---|
| Valves | ★★★★☆ | |

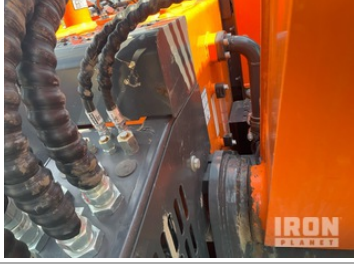
| Hydraulics | | |
|---|---|---|
| Hydraulic Tank | ★★★★☆ | |

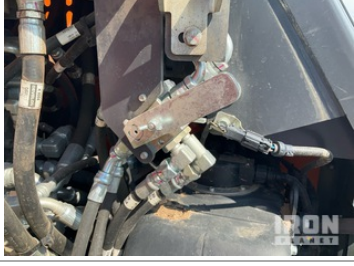
| Hydraulics | | |
|---|---|---|
| Hydraulic Control Pattern Changer | ★★★★☆ | |

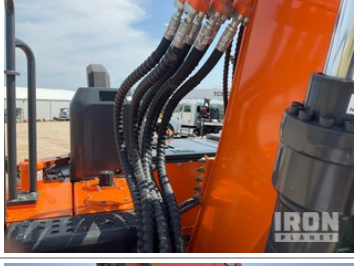
| Hydraulics | | |
|---|---|---|
| Hoses (Hydraulics) | ★★★★☆ | |

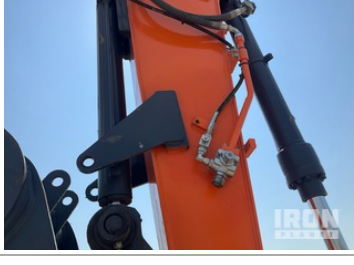
| Hydraulics | | |
|---|---|---|
| Auxiliary Hydraulic Plumbing | Operational, Capped off, End of stick | |

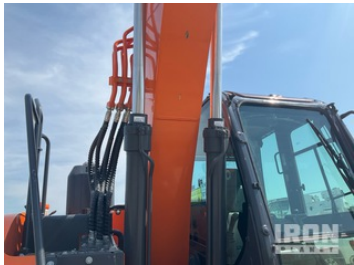
| Boom Lift Cylinder(s) | ★★★★☆ | |

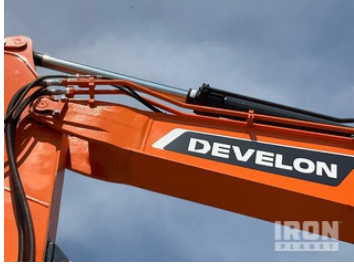
| Stick Cylinder | ★★★★☆ | |

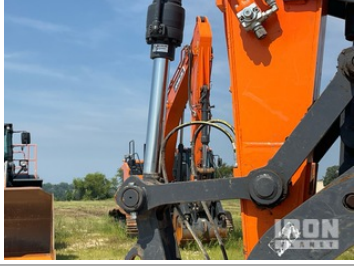
| Bucket Cylinder | ★★★★☆ | |

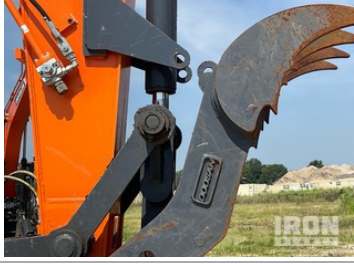
| Thumb Cylinder | ★★★★☆ | |

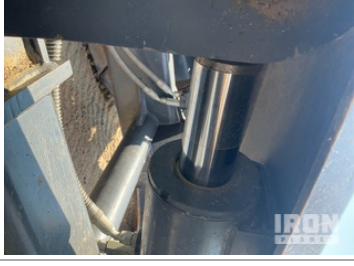
| Blade Lift Cylinder | ★★★★☆ | |

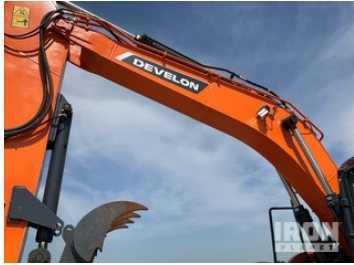
| Chassis | | |
|---|---|---|
| Boom Condition | ★★★★☆ | |

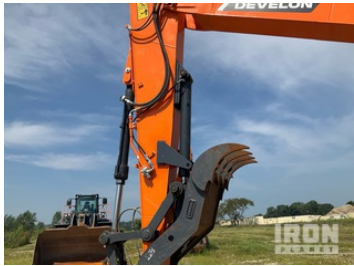
| Chassis | | |
|---|---|---|
| Stick Condition | ★★★★☆ | |

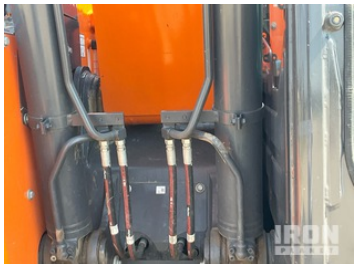
| Chassis | | |
|---|---|---|
| Boom Base Pin and Bushings | ★★★★☆ | |

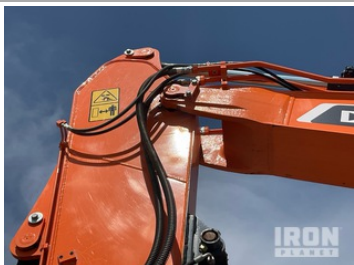
| Chassis | | |
|---|---|---|
| Pin and Bushings Boom to Stick | ★★★★☆ | |

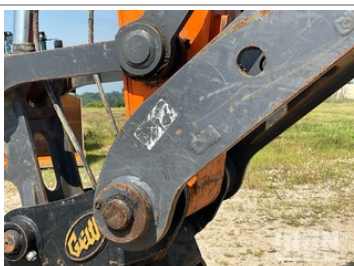
| Chassis | | |
|---|---|---|
| Pins and Bushings Stick to Coupler | ★★★★☆ | |

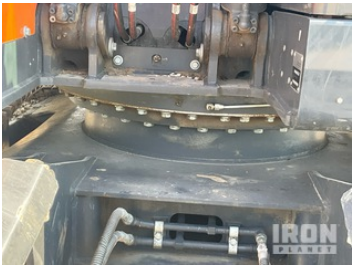
| Turntable Bearing | ☆☆☆☆ | |

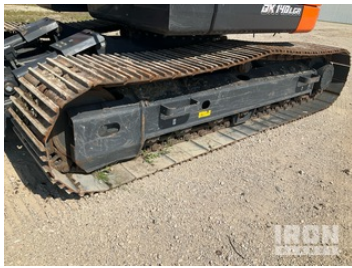
| Item | Assessment | Photo |
|---|---|---|
| Left Roller Frame | ★★★★☆ | |

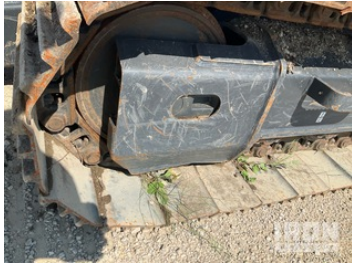
| Item | Assessment | Photo |
|---|---|---|
| Left Track Tensioner | ★★★★☆ | |

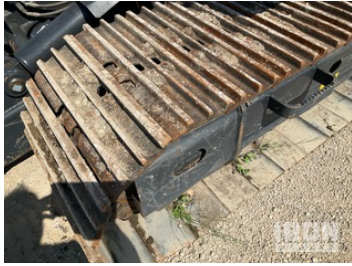
| Item | Assessment | Photo |
|---|---|---|
| Left Track Pads | ★★★★☆<br>23.5 in Wide Triple Grouser | |

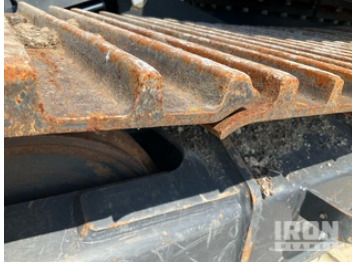
| Item | Assessment | Photo |
|---|---|---|
| Left Grouser Height | 25 mm | |

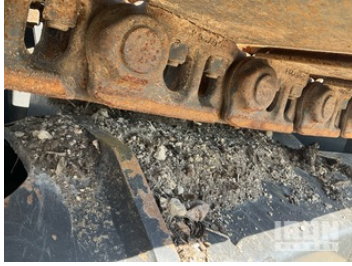
| Item | Assessment | Photo |
|---|---|---|
| Left Track Links | 94 mm | |

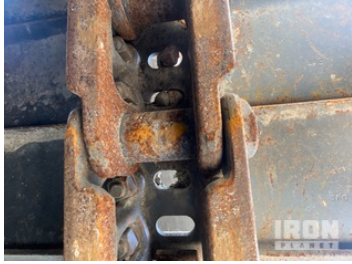
| Item | Assessment | Photo |
|---|---|---|
| Left Track Bushings | 52 mm | |

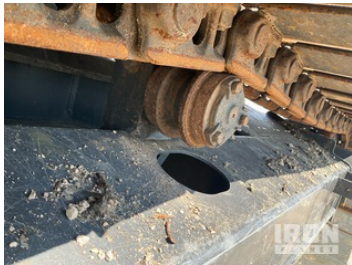
| Left Carrier Rollers | 1 carrier rollers #1 117 mm | |

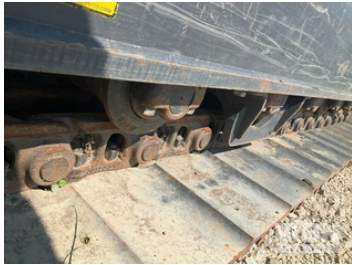
| Left Bottom Rollers | 7 Bottom Rollers #1 139 mm #2 139 mm #3 139 mm #4 139 mm #5 139 mm #6 139 mm #7 139 mm | |

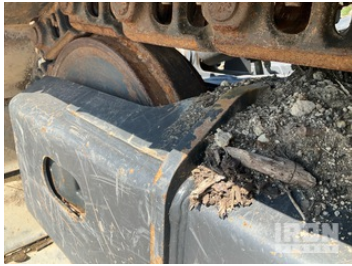
| Left Idler | 18 mm | |

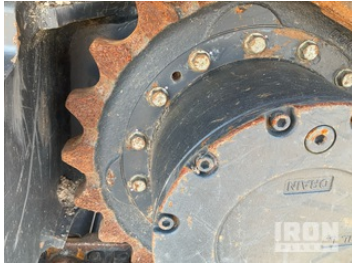
| Left Sprocket | ★★★★☆ | |

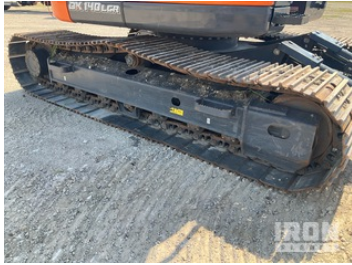
| Right Roller Frame | ★★★★☆ | |

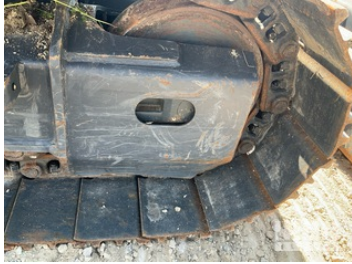
| Right Track Tensioner | ★★★★☆ | |

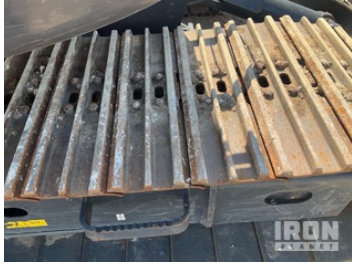
| Right Track Pads | ★★★★☆<br>23.5 in Wide Triple Grouser | |

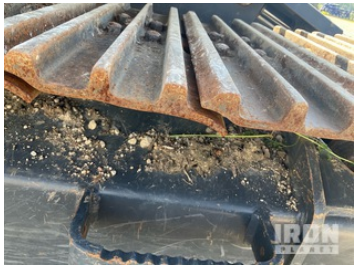
| Right Grouser Height | 25 mm | |

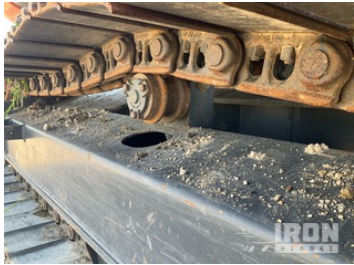
| Right Track Links | 94 mm | |

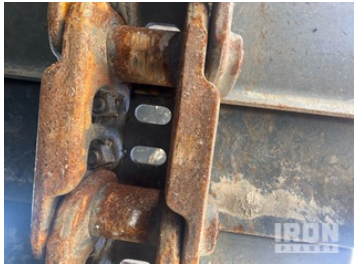
| Right Track Bushings | 52 mm | |

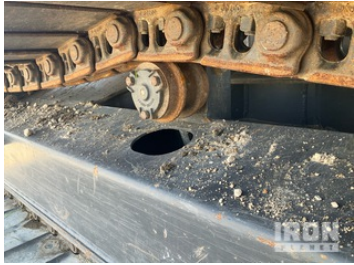
| Right Carrier Rollers | 1 Carrier Rollers #1 117 mm | |

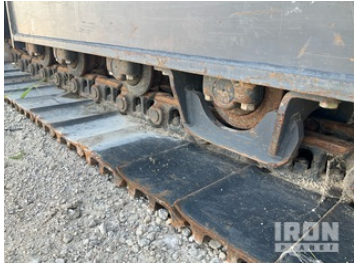
| Right Bottom Rollers | 7 Bottom Rollers: #1 139 mm #2 139 mm #3 139 mm #4 139 mm #5 139 mm #6 139 mm #7 139 mm | |

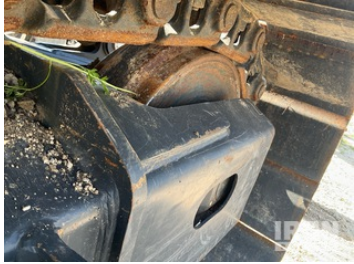
| Right Idler | 19 mm | |

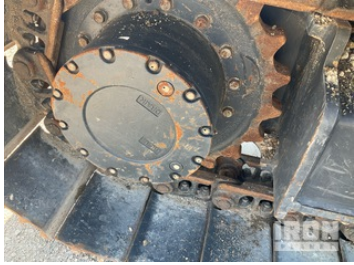
| Right Sprocket | ★★★★☆ | |

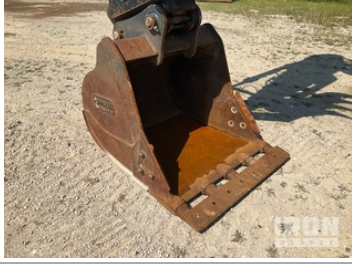
| Specialty | | |
|---|---|---|
| Excavator Bucket Condition | ★★★★☆<br>Coupler | |

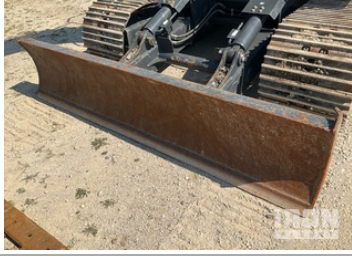
| Specialty | | |
|---|---|---|
| Blade Condition | ★★★★☆ | |

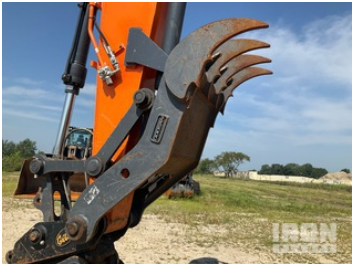
| Thumb | <div>★★★★☆</div> <div>Hydraulic thumb</div> | |
