Item #15091758 - 2020 Doosan DL200-5 Wheel Loader

Inspection Report

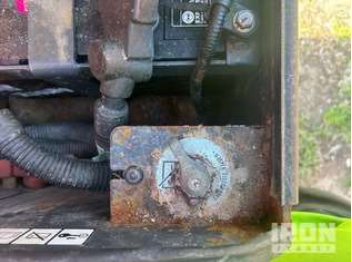
| Item | Assessment | Photo |
|---|---|--|
| Safety Lock Out/Stop | Operational | |

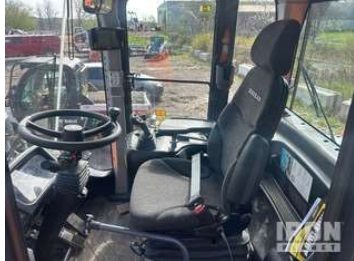
| Item | Assessment | Photo |
|---|---|--|
| Seat/Armrests | No visible damage or missing components | |

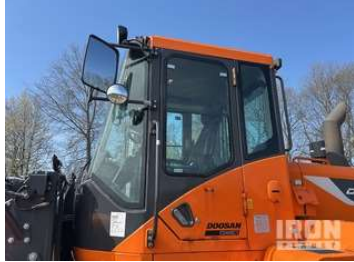
| Item | Assessment | Photo |
|---|---|--|
| Glass | No visible damage or missing components | |

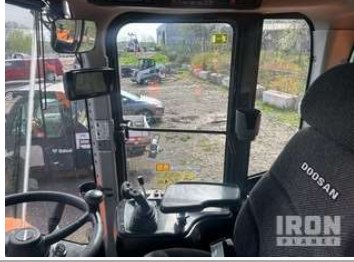
| Item | Assessment | Photo |
|---|---|--|
| Cab Doors | No visible damage or missing components | |

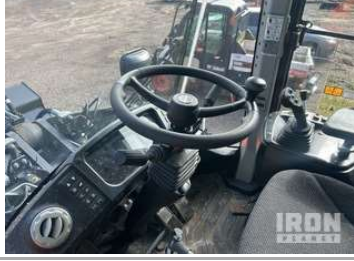
| Item | Assessment | Photo |
|---|---|--|
| Steering Controls | ★★★★☆ | |

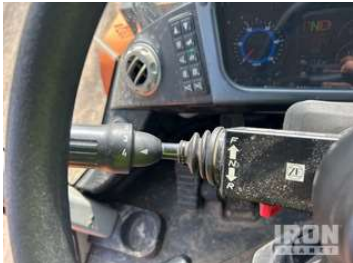
| Drivetrain Controls | ★★★★☆ | |

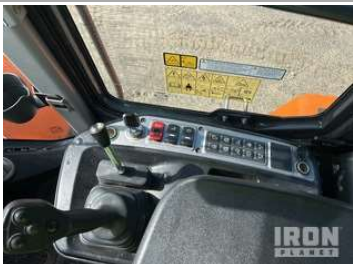
| Dash Console | ★★★★☆ | |

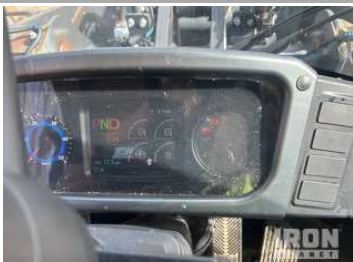
| Engine Oil Pressure | The gauge registers in the operating range. | |

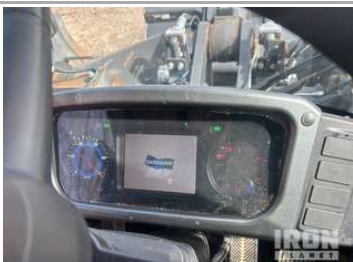
| Warning Lights | Operational | |

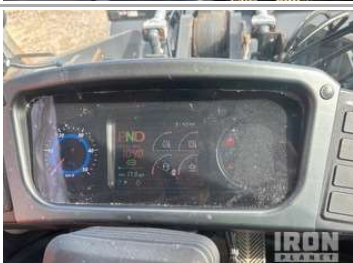
| Gauges | Operational | |

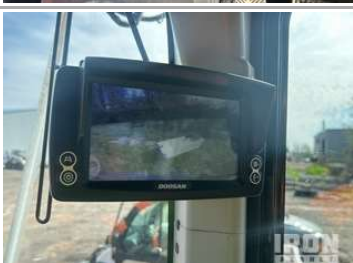
| Rear View Camera | Camera operates as intended | |

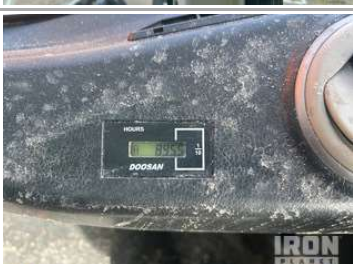
| Hour Meter / Odometer | 895 hrs | |

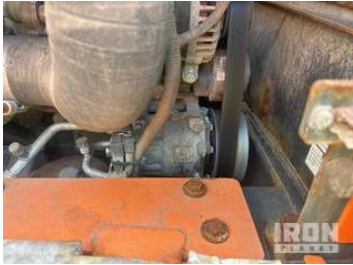
| Engine | | |
|---|--|--|
| A/C Compressor | Operational | |

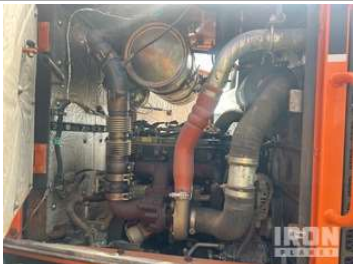
| Engine | | |
|---|--|--|
| Exhaust System | No visible damage or missing components | |

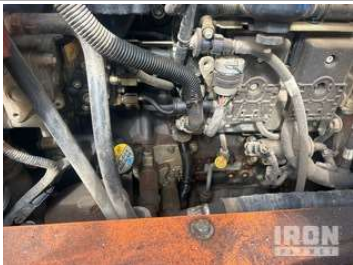
| Engine | | |
|---|--|--|
| Oil Leaks | No dripping leaks | |

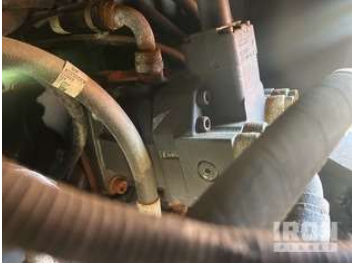
| Item | Assessment | Photo |
|---|---|--|
| Drive/Propel Motors | ★★★★☆ | |

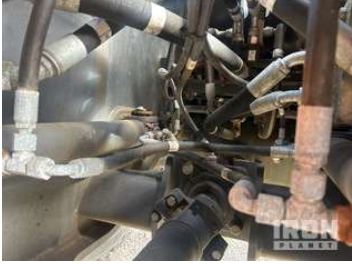
| Item | Assessment | Photo |
|---|---|--|
| Transfer Case / Drop Box | ★★★★☆ Operational | |

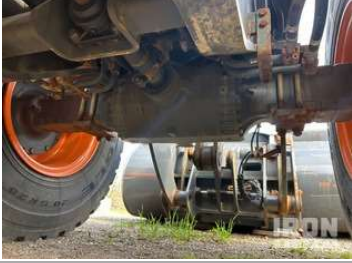
| Item | Assessment | Photo |
|---|---|--|
| Front Drive Axle | ★★★★☆ | |

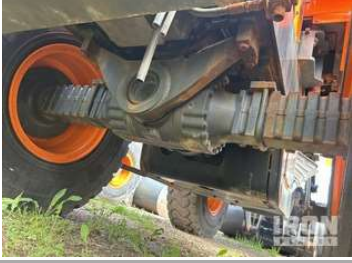
| Item | Assessment | Photo |
|---|---|--|
| Rear Drive Axle | ★★★★☆ | |

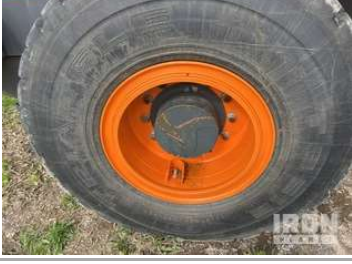
| Item | Assessment | Photo |
|---|---|--|
| Final Drives | ★★★★☆ | |

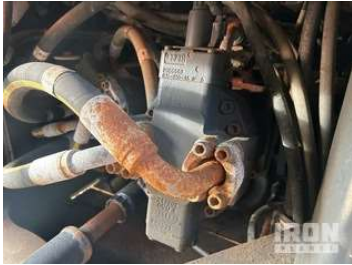
| Item | Assessment | Photo |
|---|---|--|
| Pumps (Hydraulics) | ★★★★☆ | |

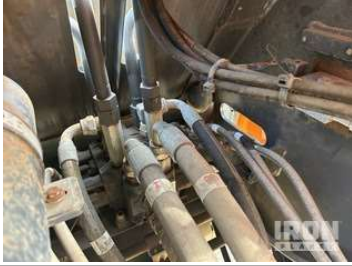
| Item | Assessment | Photo |
|---|---|--|
| Valves | ★★★★☆ | |

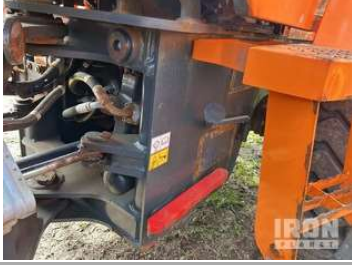
| Item | Assessment | Photo |
|---|---|--|
| Hydraulic Tank | ★★★★☆ | |

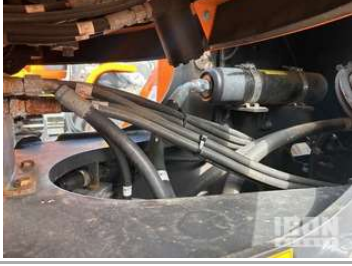
| Item | Assessment | Photo |
|---|---|--|
| Hoses (Hydraulics) | ★★★★☆ | |

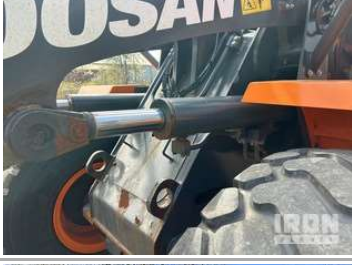
| Item | Assessment | Photo |
|---|---|--|
| Loader Lift Cylinders | ★★★★☆ | |

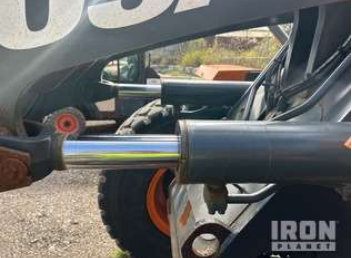
| Hydraulics #1 | | |

| Limited Function Check | The hydraulic system was operational. | |

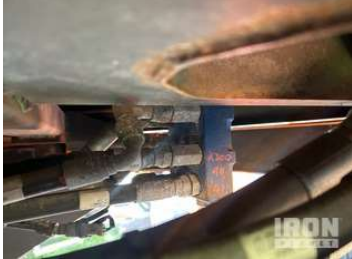
| Item | Assessment | Photo |
|---|--|--|
| Master Cylinder | ★★★★☆ | |

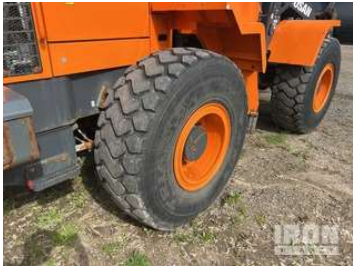
| <p>Right Rear Tire</p> | <p>★★★★☆ 27/32" Tread Depth</p> | |

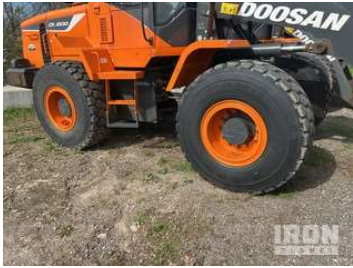
| <p>Wheel Condition</p> | <p>No visible damage or missing components</p> | |

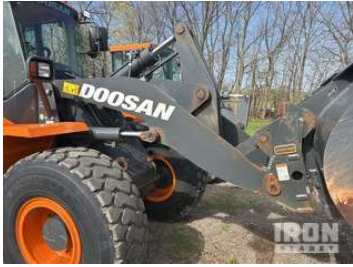
| <p>Lift Arm Condition</p> | <p>★★★★☆</p> | |

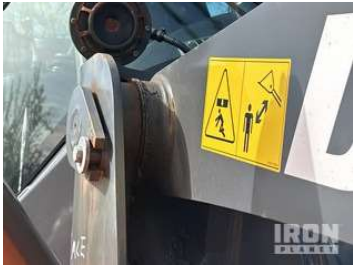
| <p>Chassis to Arm Pins</p> | <p>★★★★☆</p> | |

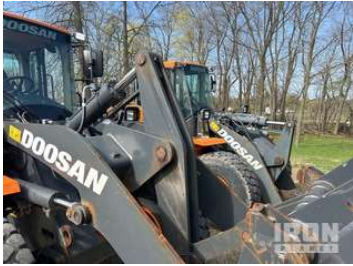
| <p>Tilt Linkage</p> | <p>★★★★☆</p> | |

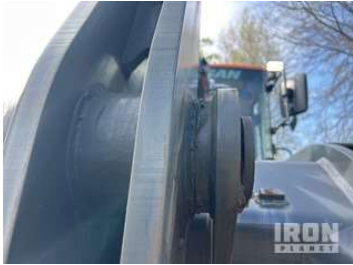
| <p>Tilt Linkage Pins and Bushings</p> | <p>★★★★☆</p> | |
