## Item #15091759 - 2020 Doosan DL200-5 Wheel Loader

# Inspection Report

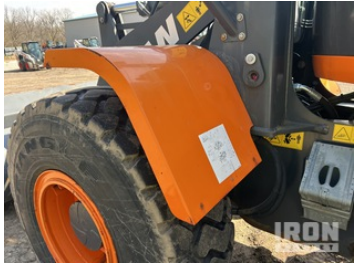
| Fenders | No visible damage or missing components. | |

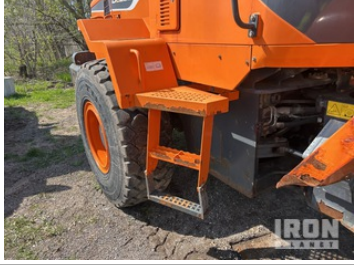
| Steps | No visible damage or missing components. | |

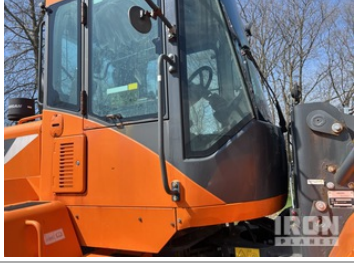
| Hand Rails | No visible damage or missing components | |

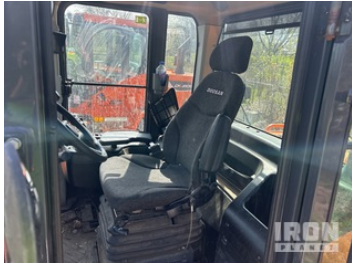
| Control Station | | |
|---|---|---|
| Seat/Armrests | No visible damage or missing components | |

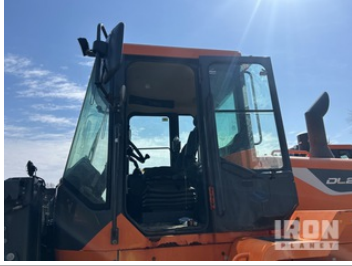
| Control Station | | |
|---|---|---|
| Glass | No visible damage or missing components | |

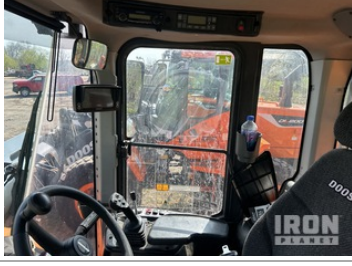
| Control Station | | |
|---|---|---|
| Cab Doors | No visible damage or missing components | |

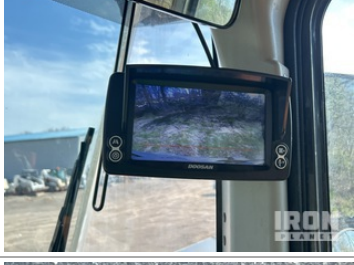
| Rear View Camera | Camera operates as intended | |

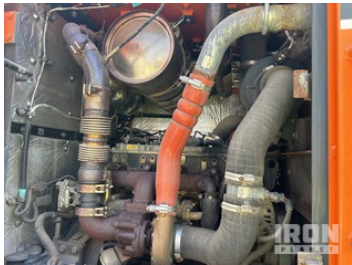
| Engine | | |
|---|---|---|
| Exhaust System | No visible damage or missing components | |

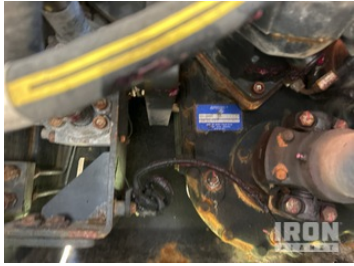
| Drivetrain | | |
|---|---|---|
| Transfer Case / Drop Box | ★★★★☆<br>Operational | |

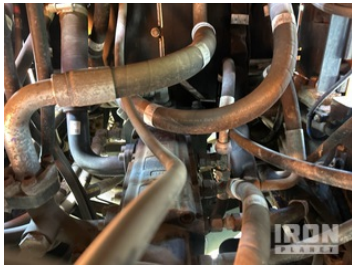
| Hydraulics | | |
|---|---|---|
| Pumps (Hydraulics) | ★★★★☆ | |

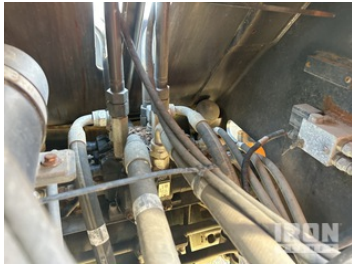
| Hydraulics | | |
|---|---|---|
| Valves | ★★★★☆ | |

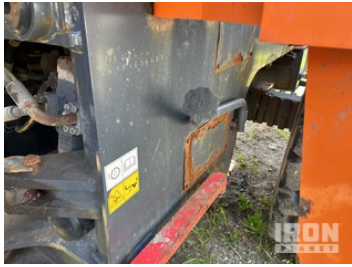
| Hydraulics | | |
|---|---|---|
| Hydraulic Tank | ★★★★☆ | |

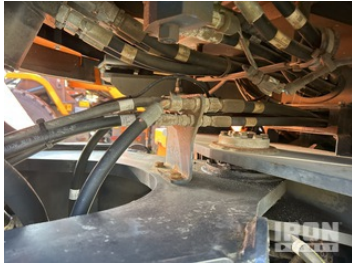
| Hydraulics | | |
|---|---|---|
| Hoses (Hydraulics) | ★★★★☆ | |

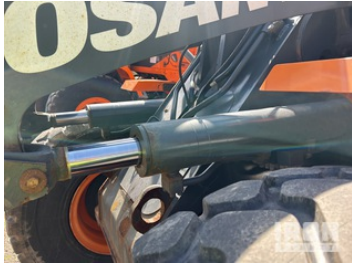
| Hydraulics | | |
|---|---|---|
| Loader Lift Cylinders | ★★★★☆ | |

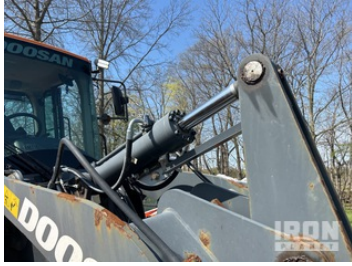
| Hydraulics | | |
|---|---|---|
| Bucket Tilt Cylinders | ★★★★☆ | |

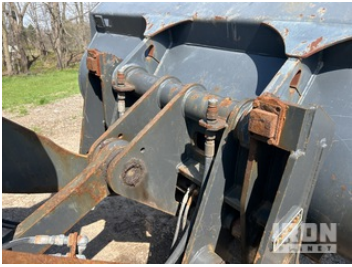
| Hydraulics #1 | | |

| Limited Function Check | The hydraulic system was operational. | |

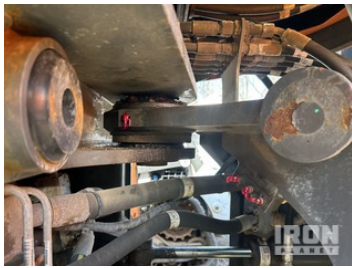
| Item | Assessment | Photo |
|---|---|---|
| Articulating Center Pins | ★★★★☆ | |

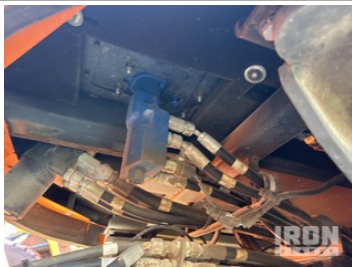
| Item | Assessment | Photo |
|---|---|---|
| Master Cylinder | ★★★★☆ | |

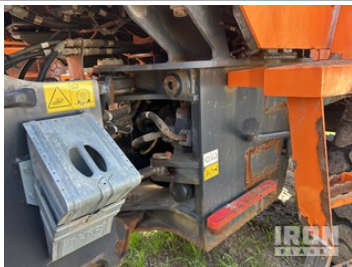
| Item | Assessment | Photo |
|---|---|---|
| Frame Condition | ★★★★☆ | |

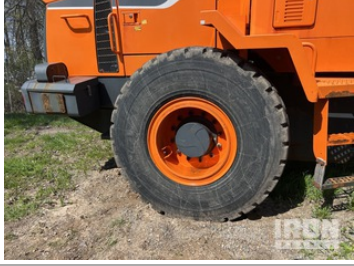
| Wheel Condition | No visible damage or missing components | |

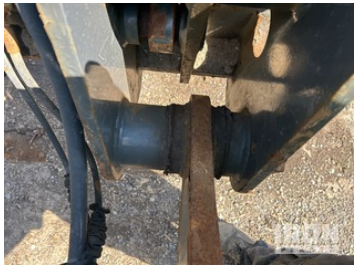
| Quick Coupler to Arms Pins | ★★★★☆ | |

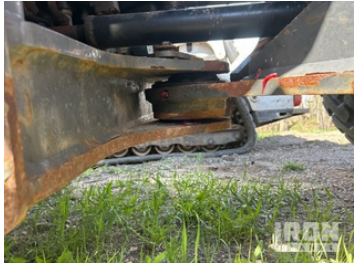
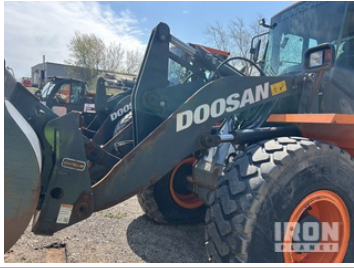
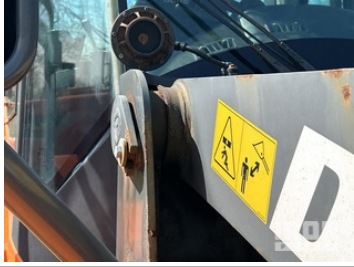
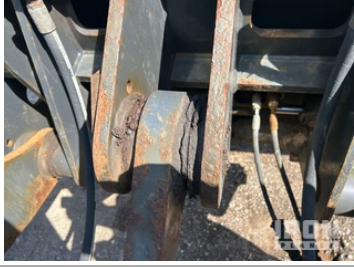
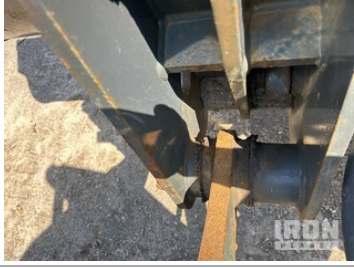
| Limited Function Check | The main chassis components were operational in a limited check. | |

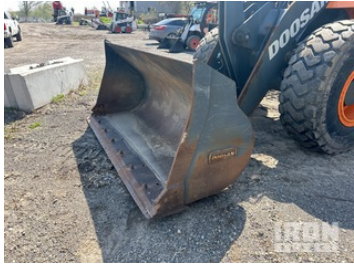
| Specialty | | |
|---|---|---|
| Loader Bucket Condition | ★★★★☆ | |

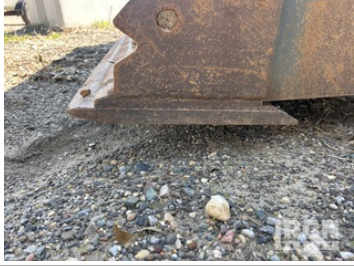
| Specialty | | |
|---|---|---|
| Loader Bucket Cutting Edge | ★★★★☆<br>No visible damage or missing components | |

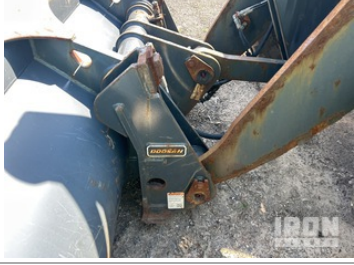
| Specialty | | |
|---|---|---|
| Loader Quick Coupler | ★★★★☆<br>Operational | |
