Item #14787771 - 2023 Develon DL250-7 High Lift Wheel Loader

Inspection Report

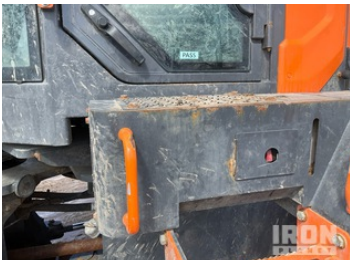
Wheel Loader* # 3

Paint	Damage	 
Body Panels	Right rear door damaged	
Fenders	Rust/ Corrosion Left, cab entry platform. DEF compartment/ Platform	 
Steps	Left cab steps damaged	 
Hand Rails	No visible damage or missing components	 
Exterior Lights	All lights operational	 
Wheel Loader* # 1

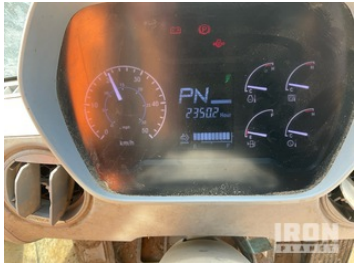
<p>Hour Meter / Odometer</p>	<p>2350 hrs</p>

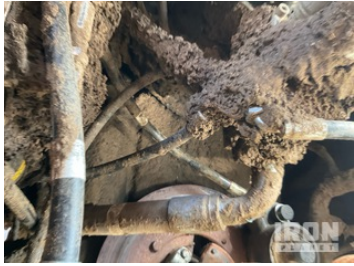
<h2>Hydraulics</h2>		
See photos for condition		
Item	Assessment	Photo
Pumps (Hydraulics)	★ ★ ★ ☆

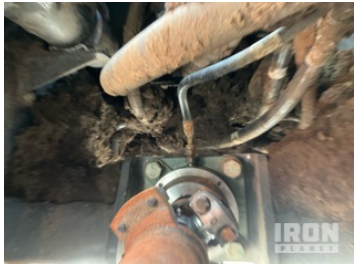
Valves	★ ★ ★ ☆

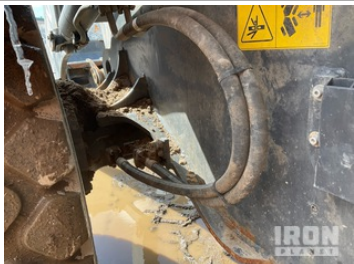
Hoses (Hydraulics)	★ ★ ★ ☆

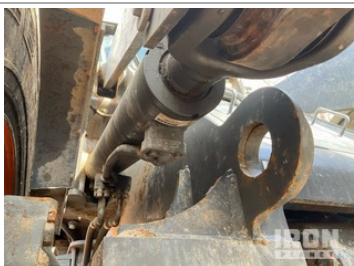
Loader Lift Cylinders	★ ★ ★ ☆

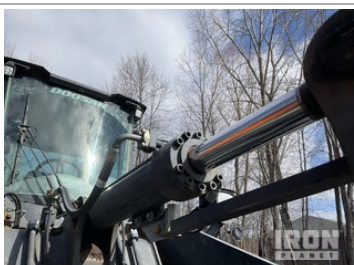
Bucket Tilt Cylinders	★ ★ ★ ☆

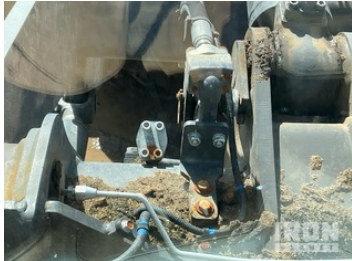
Auxiliary Hydraulic Plumbing	Capped off, Not operationally checked, Front

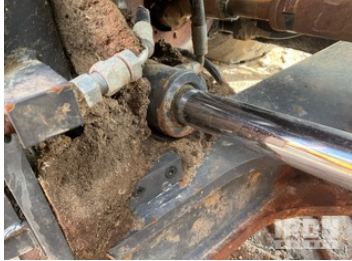
Steering Cylinders	★★★★☆

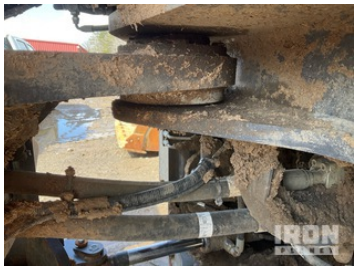
Chassis		
IronPlanet pin connection pivot point wear inspections are limited to sound, sight and feel observations. Dial indicator testing is not performed.		
Item	Assessment	Photo
Articulating Center Pins	★★★★☆

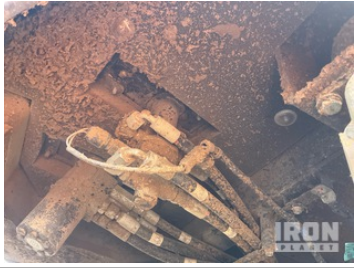
Brake Type	Hydraulic	
Master Cylinder	★★★★☆

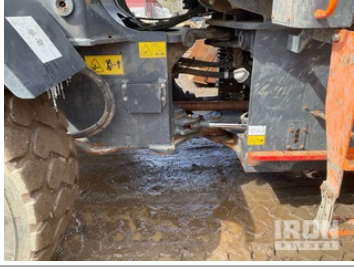
Brake Lines/Hoses	★★★★☆	
Park Brake	★★★★☆ Stopped from a slow roll	
Limited Function Check - Brakes	The brake system functioned, stopping and holding the machine.	
Frame Condition	★★★★☆

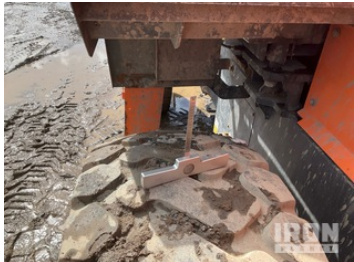
Left Rear Tire	★★★☆☆ 20/32" Tread Depth

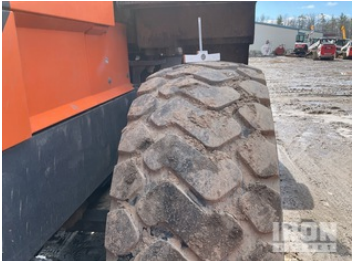
Right Rear Tire	★★☆☆ 20/32" Tread Depth

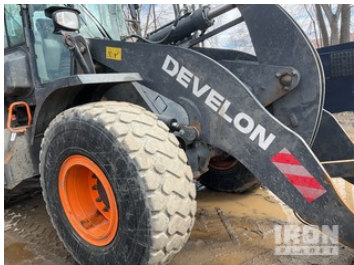
Lift Arm Condition	★★★★☆

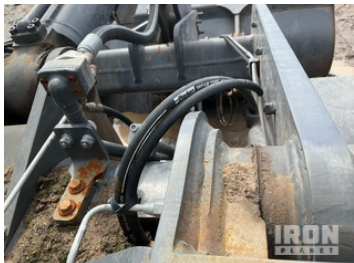
Chassis to Arm Pins	★★★★☆

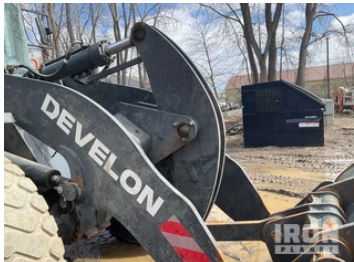
Tilt Linkage	★★★★☆

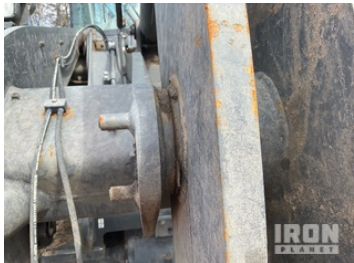
Tilt Linkage Pins and Bushings	★★★★☆

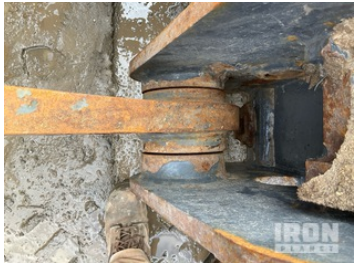
Quick Coupler to Arms Pins	★★★☆☆ excessive play for hours used

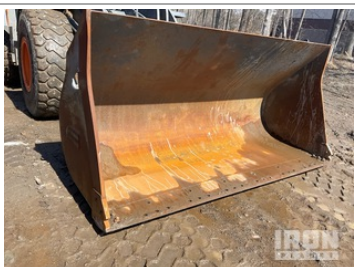
Loader Bucket Condition	★★★★☆

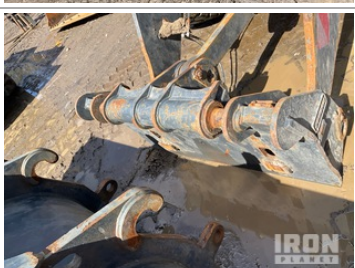
Loader Quick Coupler	★★★★☆ Doosan Coupler, Operational
