## Item #15293229 - 2021 Doosan DX420LC-5 Tracked Excavator

# Inspection Report

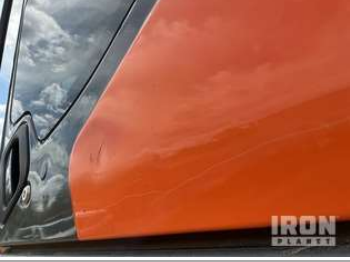
Cab Door	Door dented touch up paint over dent.

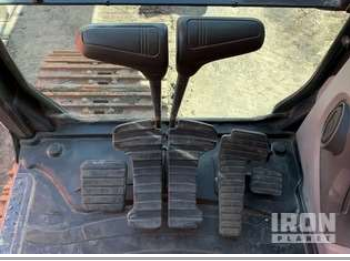
Steering Controls	★★★★☆

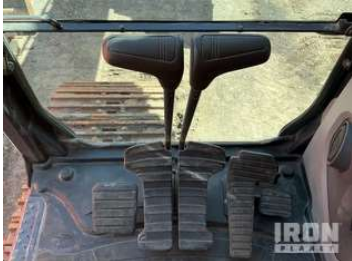
Drivetrain Controls	★★★★☆

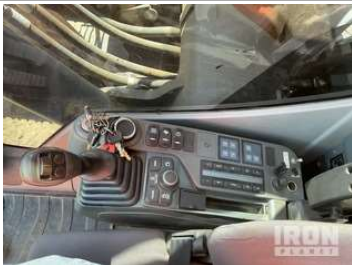
Dash Console	★★★★☆

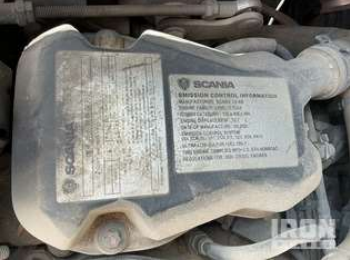
Item	Assessment	Photo
Engine	2020 US EPA Label, Requires Diesel Exhaust Fluid	
Emission Label

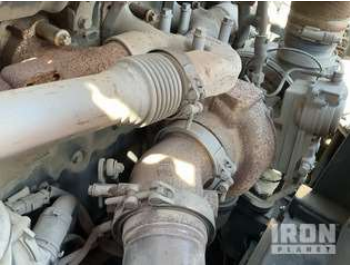
Blow-by (subjective visual observation)	No noticeable vapor or pressure	
Starter	Operational	
Exhaust System	No visible damage or missing components

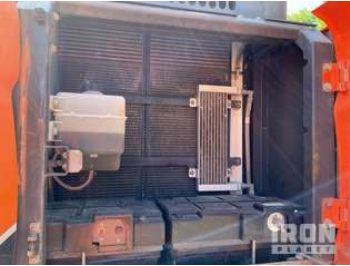
Radiator	★★★★☆

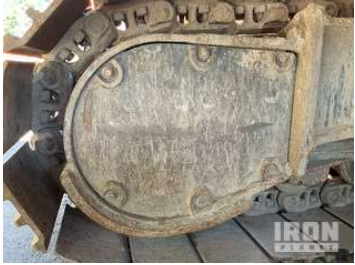
Item	Assessment	Photo
Left Drive Motor	★ ★ ★ ☆

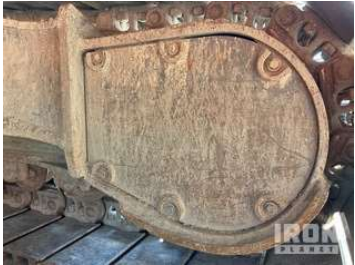
Right Drive Motor	★ ★ ★ ☆

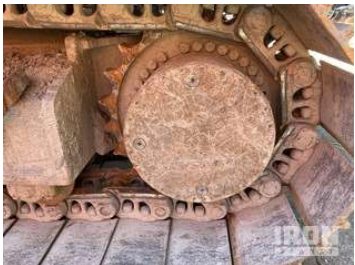
Left Final Drive	★ ★ ★ ☆

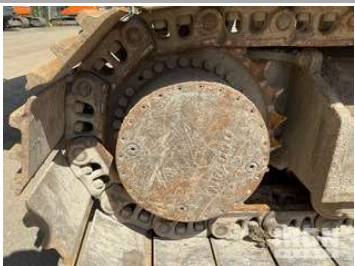
Right Final Drive	★ ★ ★ ☆

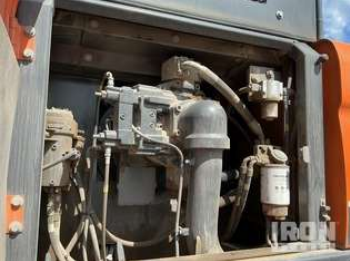
Item	Assessment	Photo
Pumps (Hydraulics)	★★★★☆

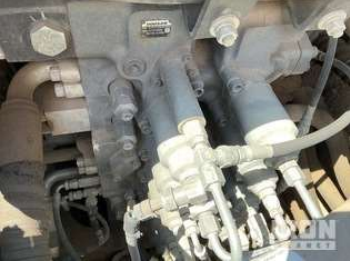
Valves	★★★★☆

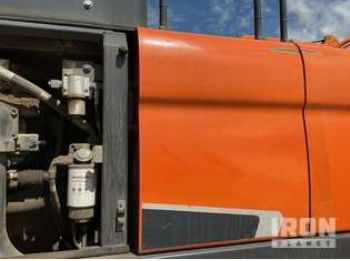
Hydraulic Tank	★★★☆☆ Low fluid level

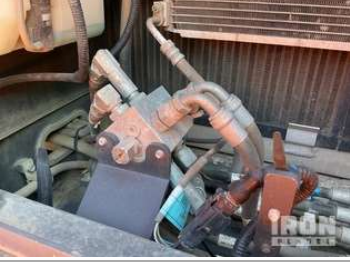
Hydraulic Control Pattern Changer	★★★★☆

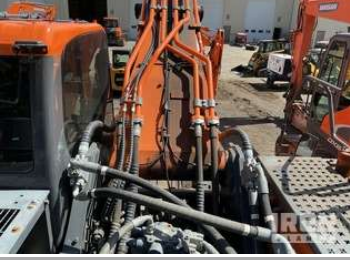
Hoses (Hydraulics)	★★★★☆

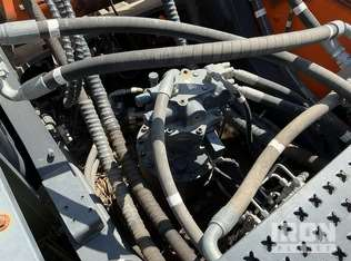
Swing Motor	★★★★☆

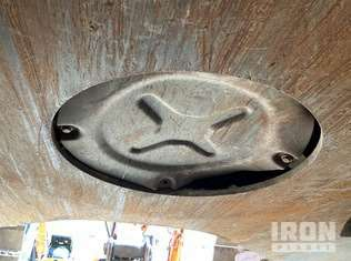
Hydraulic Center Swivel	★★★★☆

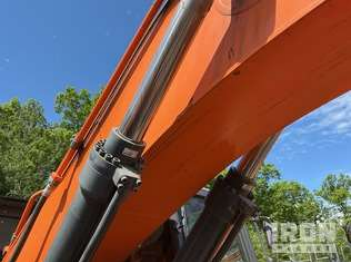
Boom Lift Cylinder(s)	★★★★☆

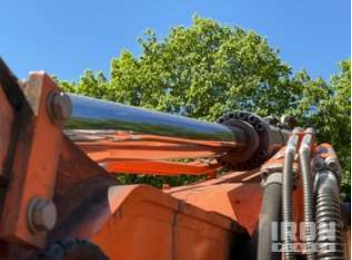
Stick Cylinder	★★★★☆

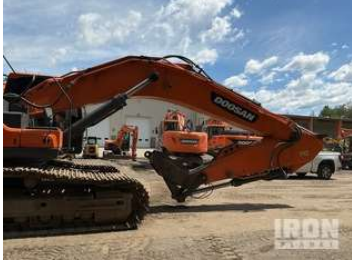
Item	Assessment	Photo
Boom Condition	★★★★☆

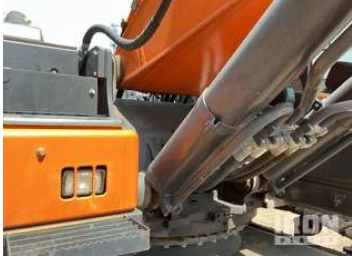
Boom Base Pin and Bushings	★★★★☆

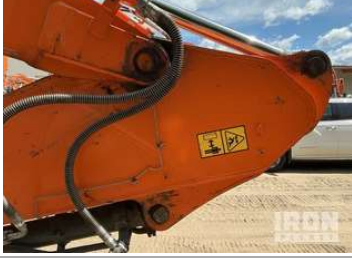
Pin and Bushings Boom to Stick	★★★★☆

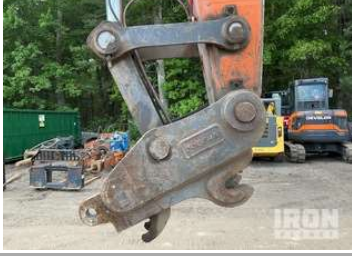
Pins and Bushings Stick to Coupler	★★★★☆

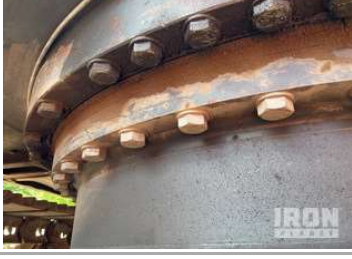
Turntable Bearing	★★★★☆

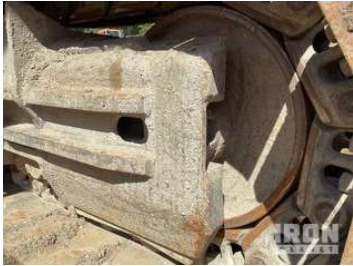
Left Track Tensioner	★★★☆☆

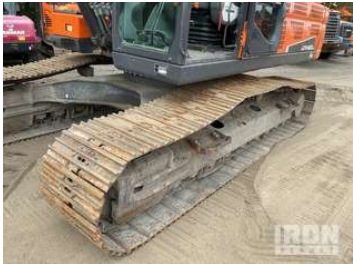
Left Track Pads	★★★☆☆ 31.5 in Wide Triple Grouser

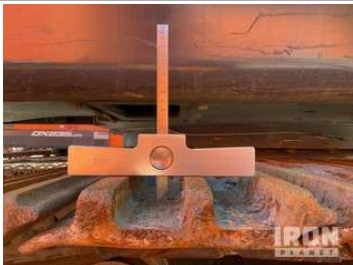
Left Grouser Height	28 mm

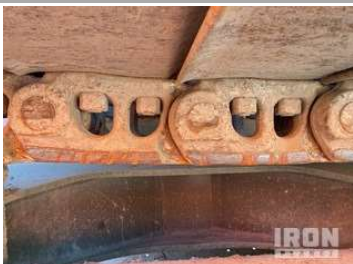
Left Track Links	128 mm

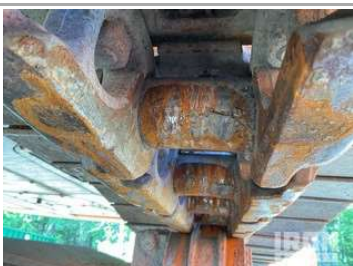
Left Track Bushings	69 mm

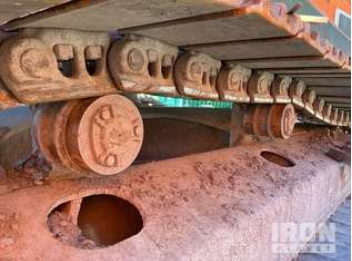
Left Carrier Rollers	2 carrier rollers #1 178 mm #2 178 mm

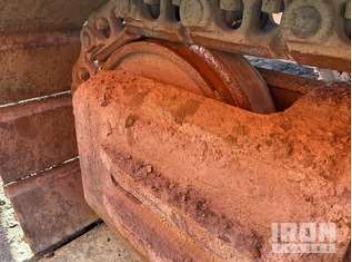
Left Idler	26 mm

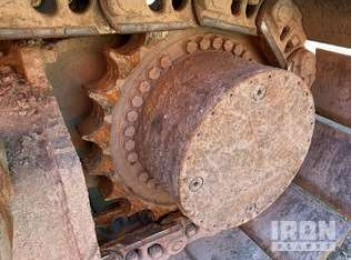
Left Sprocket	★★★★☆

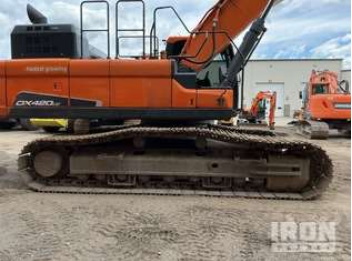
Right Roller Frame	★★★★☆

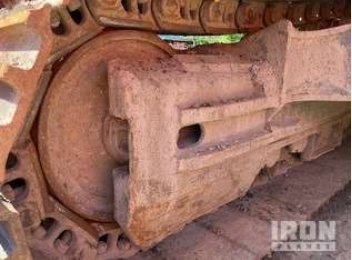
Right Track Tensioner	★★★★☆

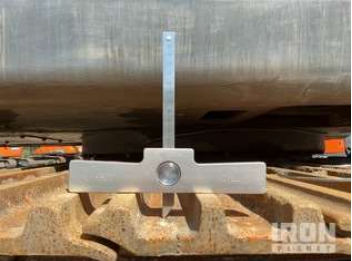
Right Grouser Height	27 mm

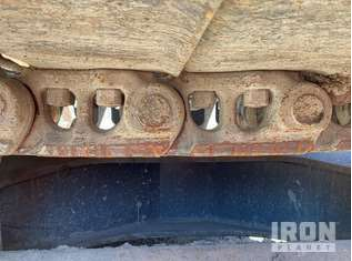
Right Track Links	128 mm

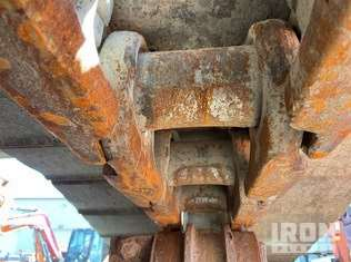
Right Track Bushings	69 mm

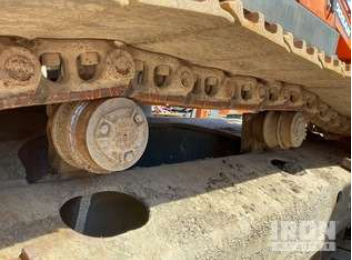
Right Carrier Rollers	2 Carrier Rollers #1 178 mm #2 178 mm

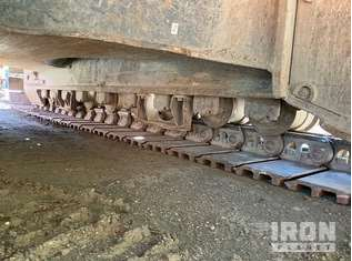
Right Bottom Rollers	9 Bottom Rollers: #1 unable to measure mm #2 unable to measure mm #3 unable to measure mm #4 unable to measure mm #5 196 mm #6 unable to measure mm #7 unable to measure mm #8 unable to measure mm #9 197 mm

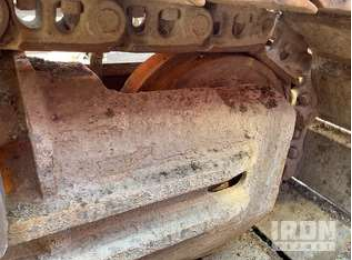
Right Idler	27 mm

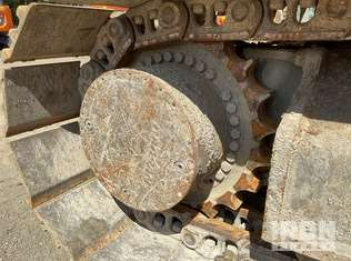
Right Sprocket	★★★★☆

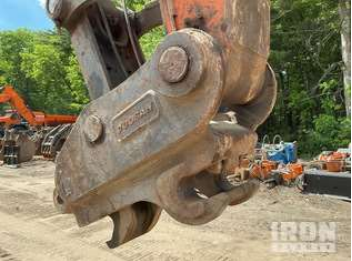
Item	Assessment	Photo
Quick Coupler	★★★★☆ Operational
