Item #15091771 - 2023 Doosan DX350LCR-7 Tracked Excavator

Inspection Report

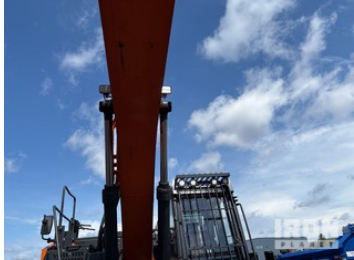
<p>Exterior Lights</p>	<p>1 Inoperable / damaged / missing</p>

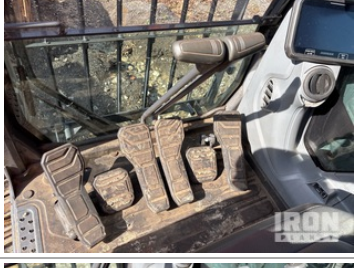
Steering Controls	★★★★☆

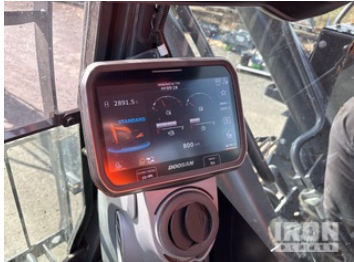
Engine Oil Pressure	No oil pressure indicator	
Warning Lights	Operational	
Gauges	Operational

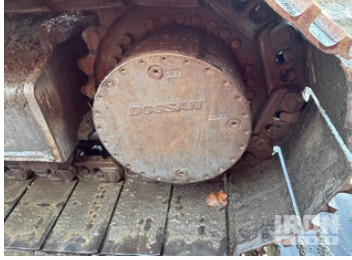
Left Final Drive	★★★★☆

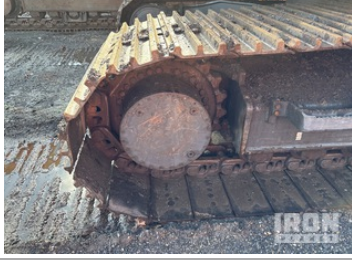
Right Final Drive	★★★★☆

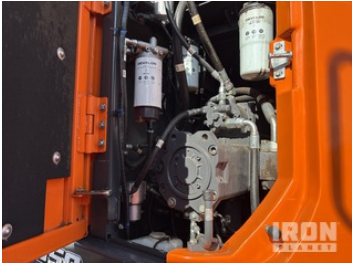
Hydraulics		
Item	Assessment	Photo
Pumps (Hydraulics)	★★★★☆

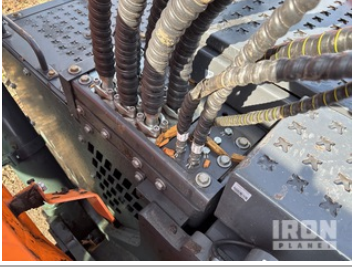
Valves	★★★★☆

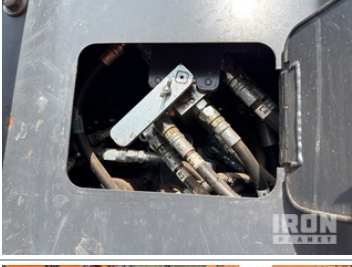
Hydraulic Control Pattern Changer	★★★★☆

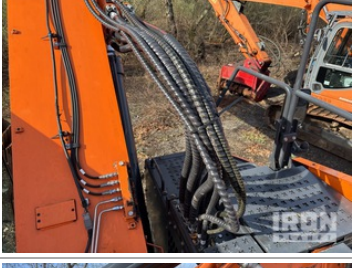
Hoses (Hydraulics)	★★★★☆

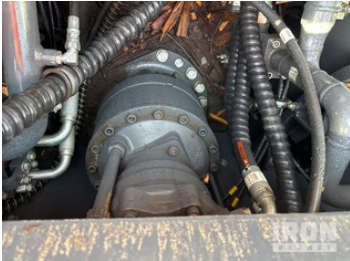
Swing Motor	★★★★☆

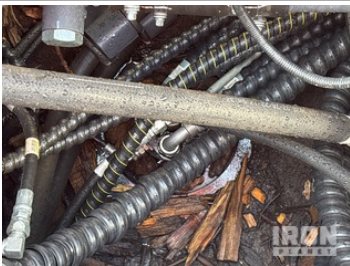
Hydraulic Center Swivel	★★★★☆

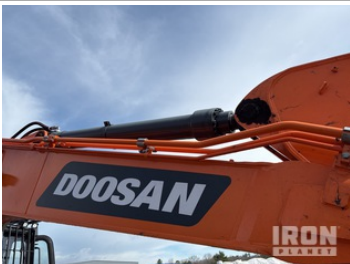
Stick Cylinder	★★★★☆

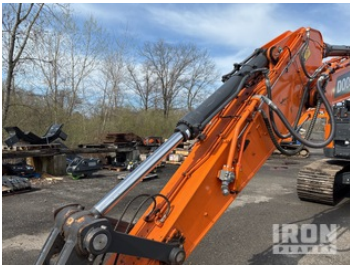
Bucket Cylinder	★★★★☆

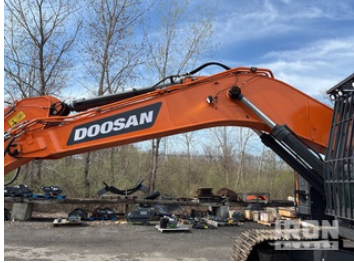
Chassis		
IronPlanet pin connection pivot point wear inspections are limited to sound, sight and feel observations. Dial indicator testing is not performed.		
Item	Assessment	Photo
Boom Condition	★★★★☆

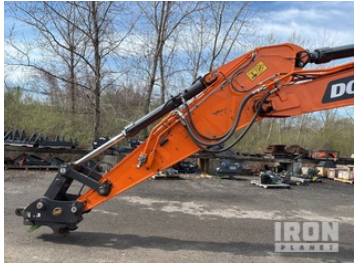
Stick Condition	★★★★☆

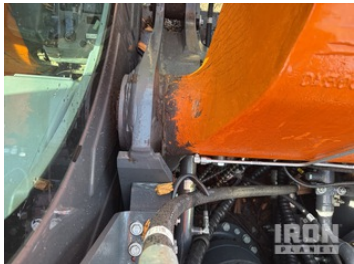
Boom Base Pin and Bushings	★★★★☆

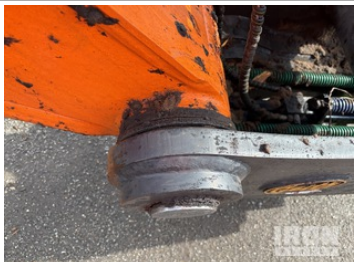
Pins and Bushings Stick to Coupler	★★★★☆

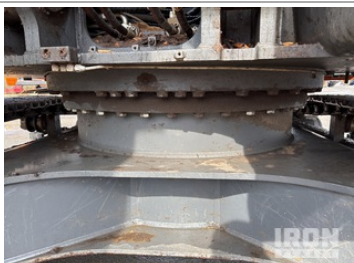
Turntable Bearing	★★★★☆

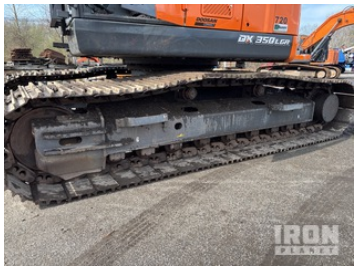
Item	Assessment	Photo
Track Link Brand	Other Doosan Other Doosan	
Left Roller Frame	★★★★☆

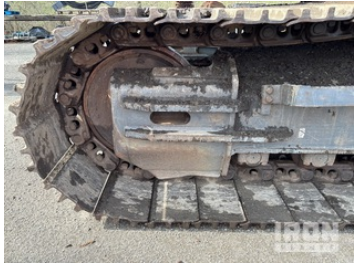
Left Track Tensioner	★★★★☆

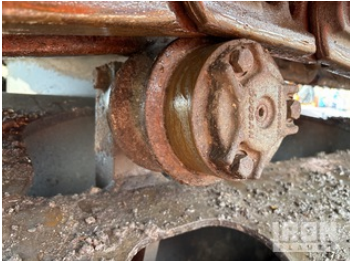
<p>Left Carrier Rollers</p>	<p>2 carrier rollers #1 139 mm #2 138 mm</p>

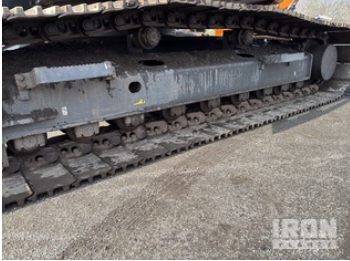
<p>Left Bottom Rollers</p>	<p>9 Bottom Rollers #1 173 mm #2 173 mm #3 173 mm #4 173 mm #5 173 mm #6 173 mm #7 173 mm #8 174 mm #9 174 mm</p>

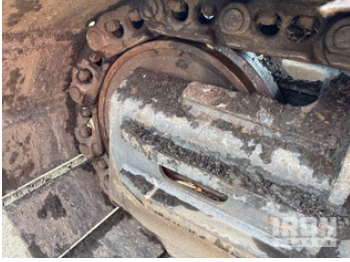
<p>Left Idler</p>	<p>25 mm</p>

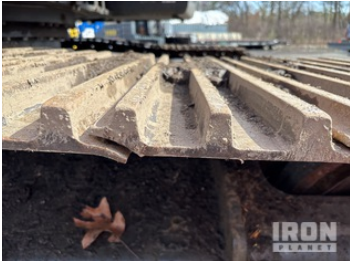
<p>Right Grouser Height</p>	<p>32 mm</p>

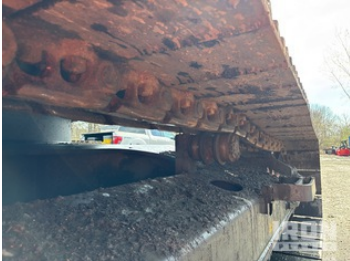
<p>Right Track Links</p>	<p>112 mm</p>

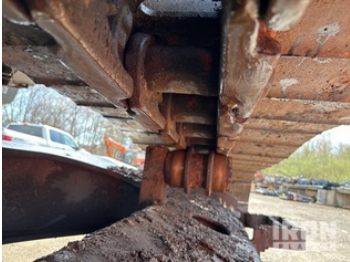
<p>Right Track Bushings</p>	<p>64 mm</p>

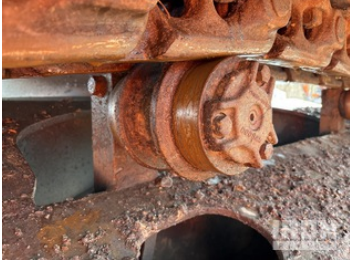
<p>Right Carrier Rollers</p>	<p>2 Carrier Rollers #1 139 mm #2 139 mm</p>

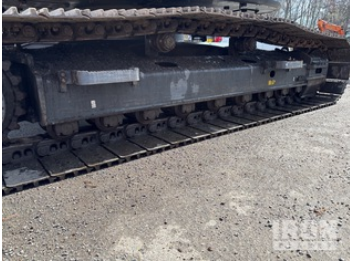
<p>Right Bottom Rollers</p>	<p>9 Bottom Rollers: #1 175 mm #2 175 mm #3 174 mm #4 174 mm #5 175 mm #6 175 mm #7 175 mm #8 175 mm #9 175 mm</p>

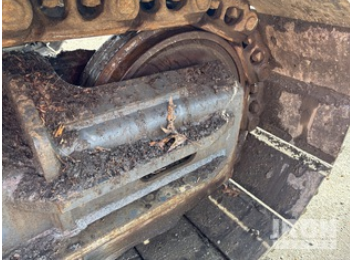
<p>Right Idler</p>	<p>25 mm</p>
