Item #15260640 - 2023 Doosan DL280-7 Wheel Loader

Inspection Report

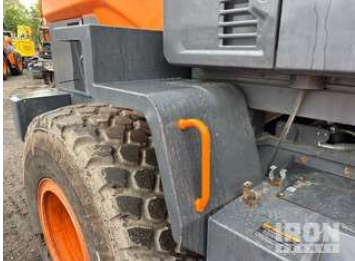
Body Panels	No visible damage or missing components.	
Fenders	No visible damage or missing components.

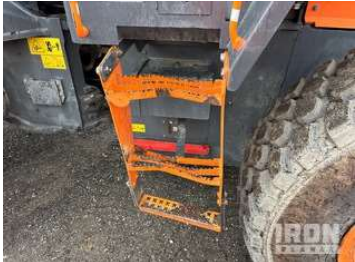
Steps	No visible damage or missing components.

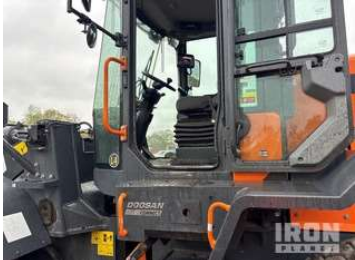
Hand Rails	No visible damage or missing components

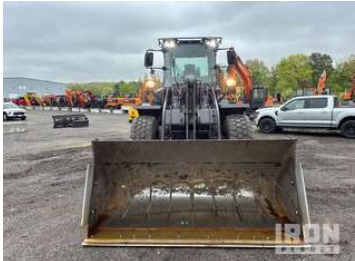
Exterior Lights	All lights operational

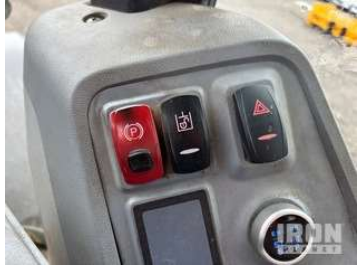
Item	Assessment	Photo
Travel Alarm	Operational	
Horn	Operational	
Seat Belts	Operational	
Safety Lock Out/Stop	Operational

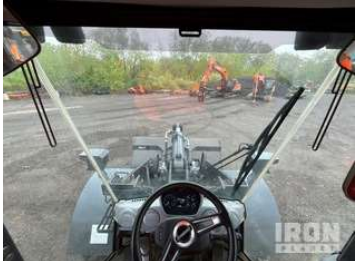
Glass	No visible damage or missing components

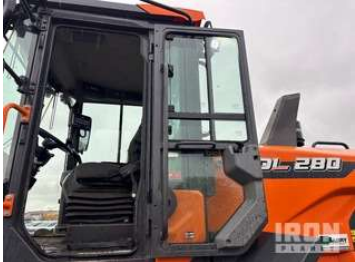
Cab Doors	No visible damage or missing components

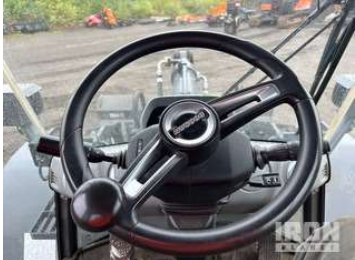
Steering Controls	★★★★☆

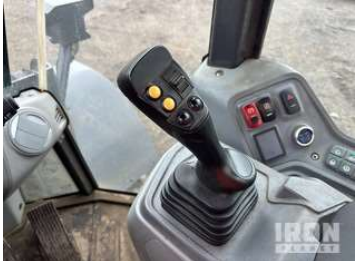
Hydraulic Controls	★★★★☆

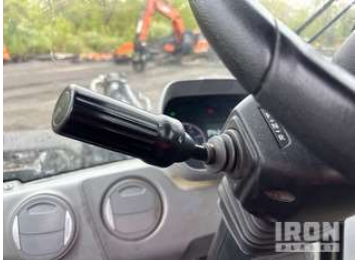
Drivetrain Controls	★★★★☆

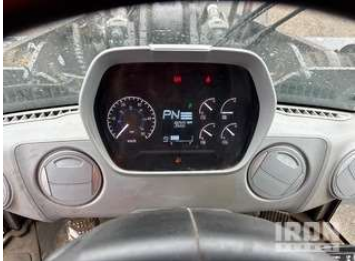
Dash Console	★★★★☆

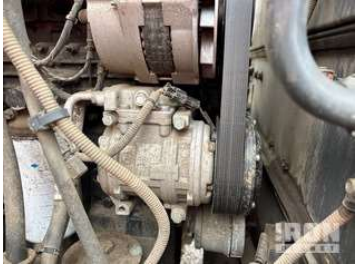
A/C Compressor	Operational

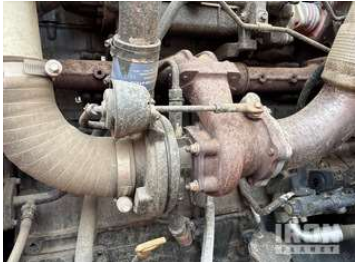
Blow-by (subjective visual observation)	No noticeable vapor or pressure	
Starter	Operational	
Exhaust System	No visible damage or missing components

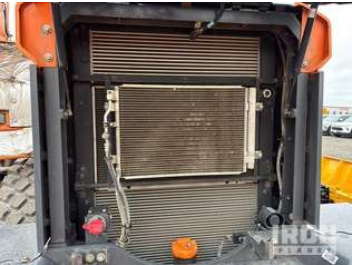
Radiator	★★★★☆

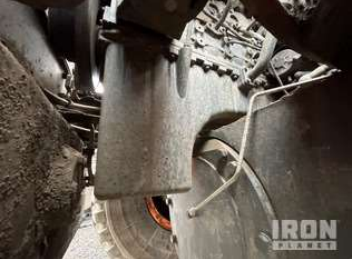
Oil Leaks	No dripping leaks

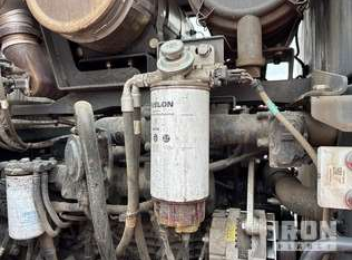
Fuel Leaks	No dripping leaks

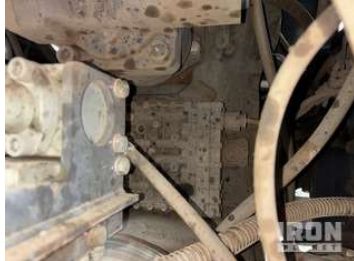
Transfer Case / Drop Box	★★★★☆ Operational

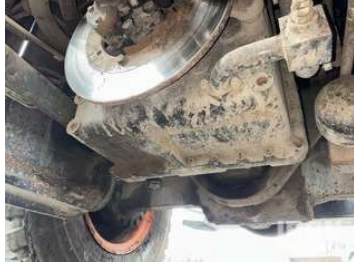
Front Drive Axle	★★★★☆

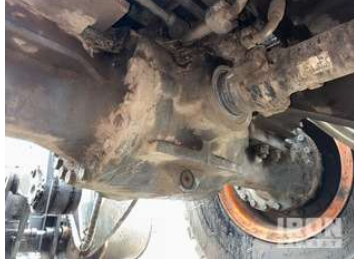
Rear Drive Axle	★★★★☆

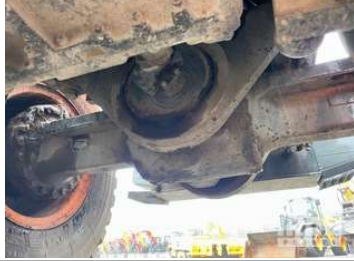
Final Drives	★★★★☆

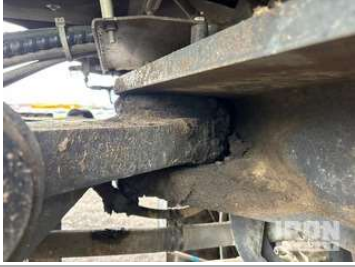
Item	Assessment	Photo
Articulating Center Pins	★★★★☆

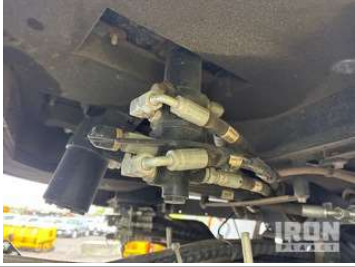
Brake Type	Hydraulic	
Master Cylinder	★★★★☆

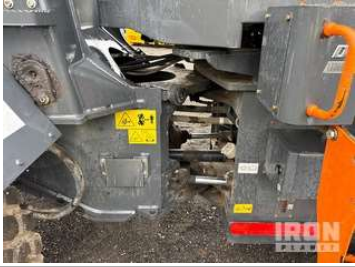
Brake Lines/Hoses	★★★★☆	
Park Brake	★★★★☆	
Limited Function Check - Brakes	The brake system functioned, stopping and holding the machine.	
Frame Condition	★★★★☆

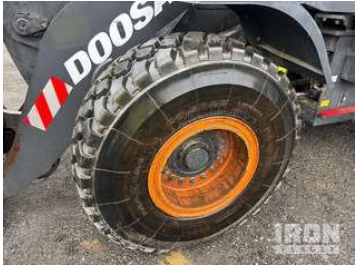
Left Front Tire	★★★★☆ Maxam MS330 20.5R25 38/32" Tread Depth

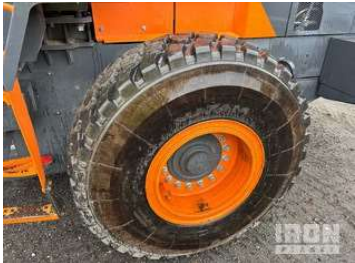
Left Rear Tire	★★★★☆ Maxam MS330 20.5R25 38/32" Tread Depth

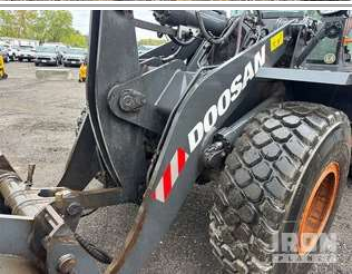
Lift Arm Condition	★★★★☆

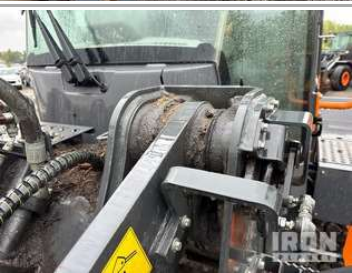
Chassis to Arm Pins	★★★★☆

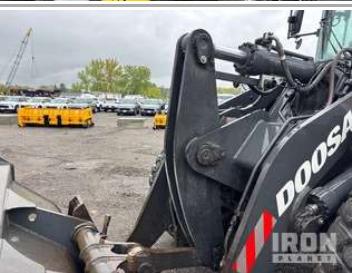
Tilt Linkage	★★★★☆

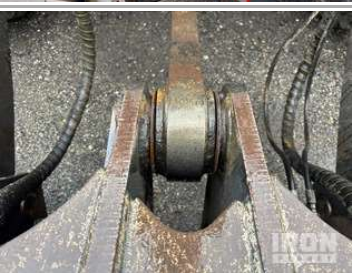
Tilt Linkage Pins and Bushings	★★★★☆

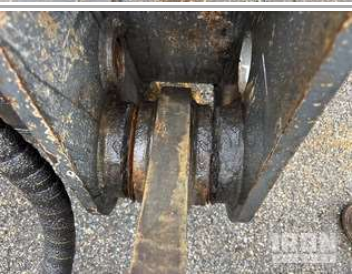
Quick Coupler to Arms Pins	★★★★☆

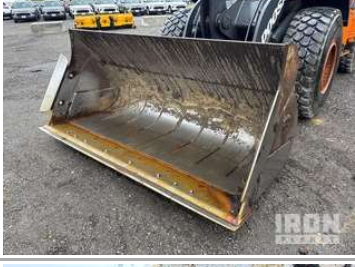
Specialty #4		 
Loader Bucket Condition	<p>★★★★☆</p>
